The Lorca Earthquake

Effects on buildings

INTEMAC

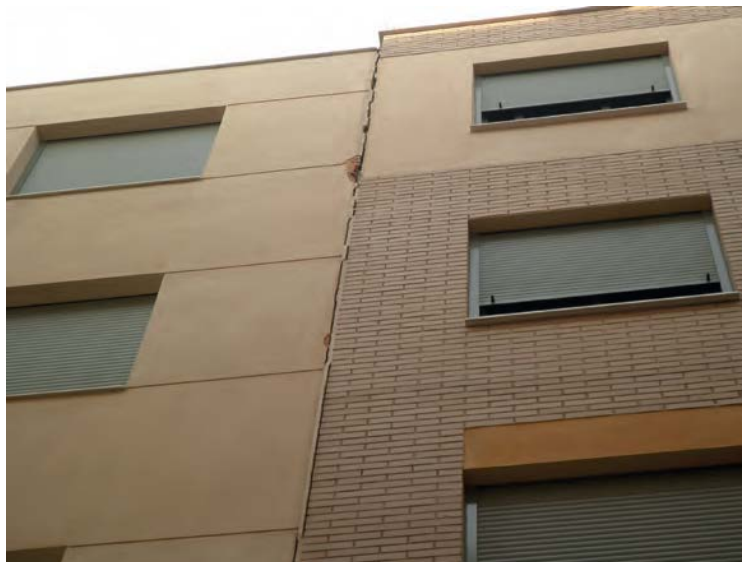
▲ Photograph 1-9

In most cases no real joint is visible between the party wall buildings. The separation generally consists of polystyrene panelling (Photograph 1-9), which in the most recent buildings is sealed with silicone along the façade. At roof level, however, the joints are sealed with mortar to prevent leaking (Photograph 1-10).

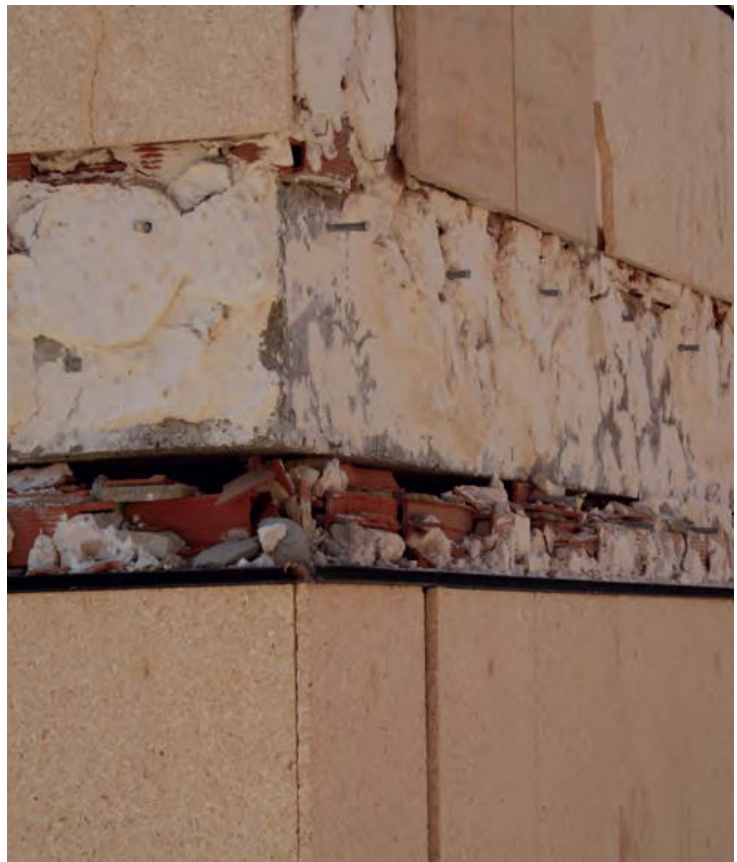
▲ Photograph 2-10

A high percentage of façade panelling, especially decorative panels on ground storeys, fell away (Photograph 2-10), revealing attachment systems of such dubious quality in most cases that they would be regarded as unacceptable even in non-seismic regions. This issue will be revisited throughout the present discussion: much of the post-earthquake damage is attributable less to the quake itself than to the use of unsafe construction systems.

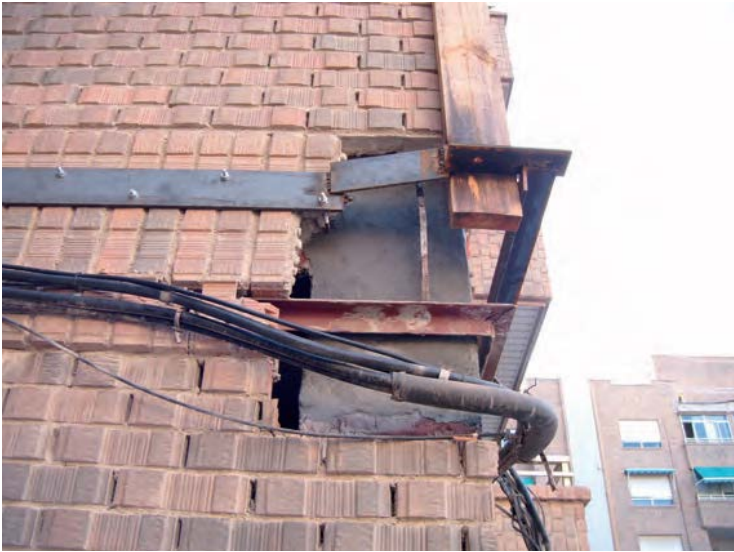
▲ Photograph 5-11

Nonetheless, the greatest hazard exists when the masonry façade is positioned off a slab resting on a steel shape, in turn hung from mere tie rods (Photograph 5-11: note the supporting angle clip and above it, the tie bands attached after the earthquake to provisionally secure the façade). This arrangement is scanty reliable even for gravity loads.

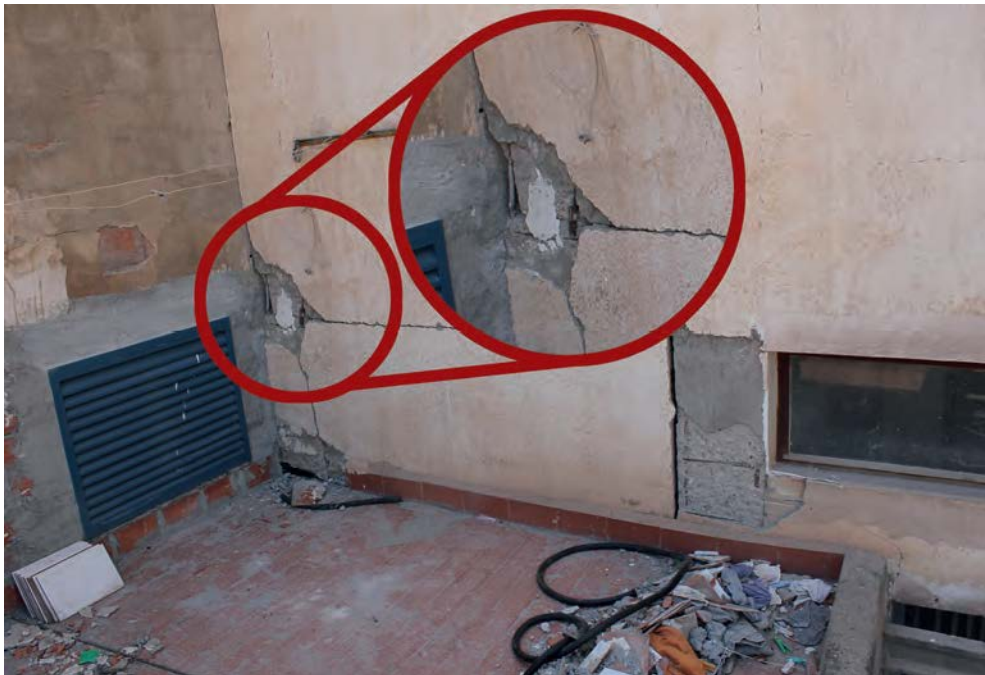
▲ Photograph 6-7

This type of failure was observed fairly frequently in Lorca, particularly in corner columns, such as in Photograph 6-7.

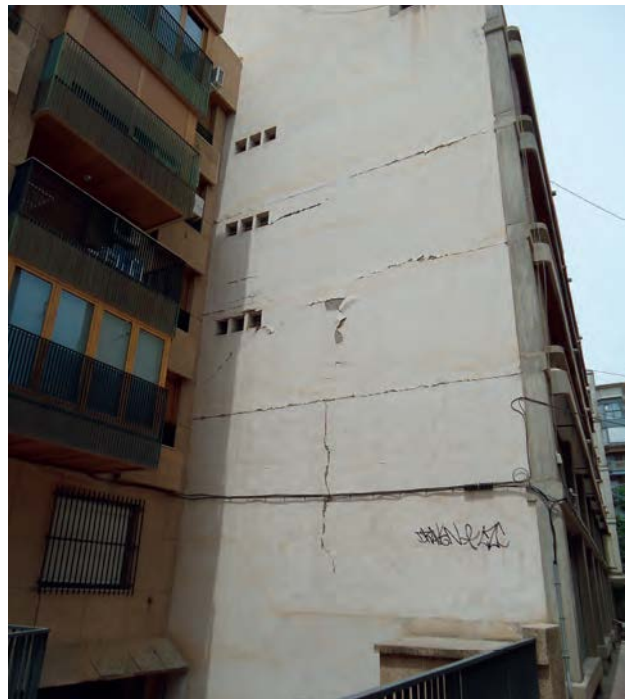
▲ Photograph 6-10

At Lorca, damage was consistently observed at the frame-infill interface, as shown in Photograph 6-10, although this is not, strictly speaking, a failure mode, for it involves a loss of stiffness but not of strength. Failure types similar to the ones described earlier were also identified. Photograph 6-11 depicts a masonry wall crushed at the corners and Photograph 6-12 mortar joint failure.

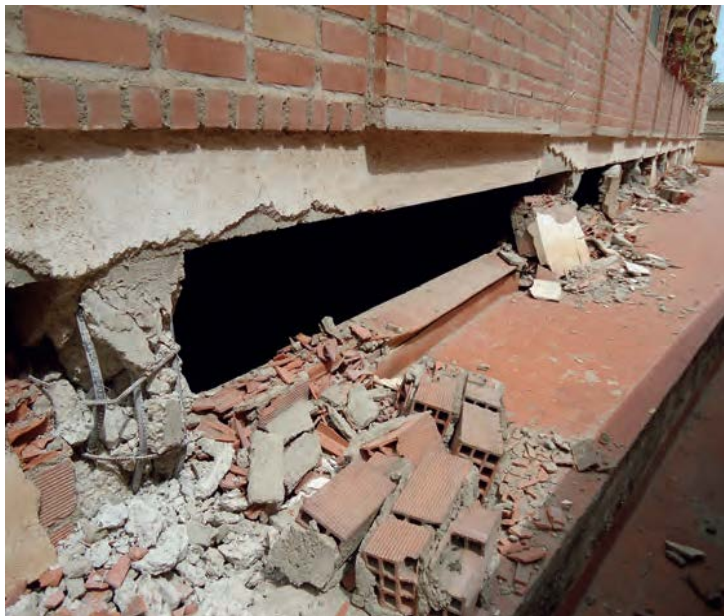
▲ Photograph 7-1

One such situation, depicted in Photograph 7-1, was found in columns aligned with semi-basement façades.

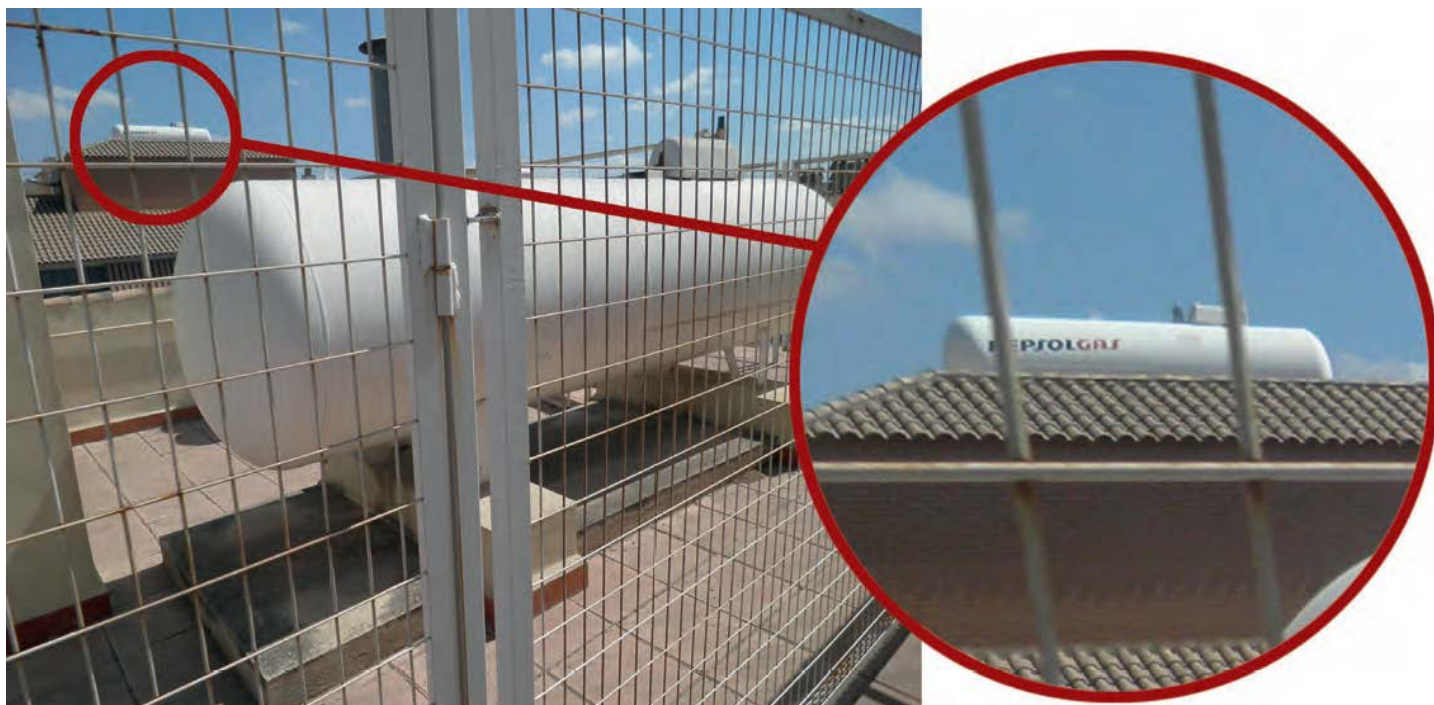
▲ Photograph 7-13

Another equally astonishing finding was the number of fuel tanks positioned on roofs, systematically in some quarters (Photograph 7-13). Inasmuch as seismic acceleration on the roof was observed to be much greater than at ground level and usually on the order of 1 g, the magnitude of the actions induced by these tanks in the structure can be readily deduced (bearing in mind that such actions are the resultants of the self-weight not only of the deposit, but also of its base).

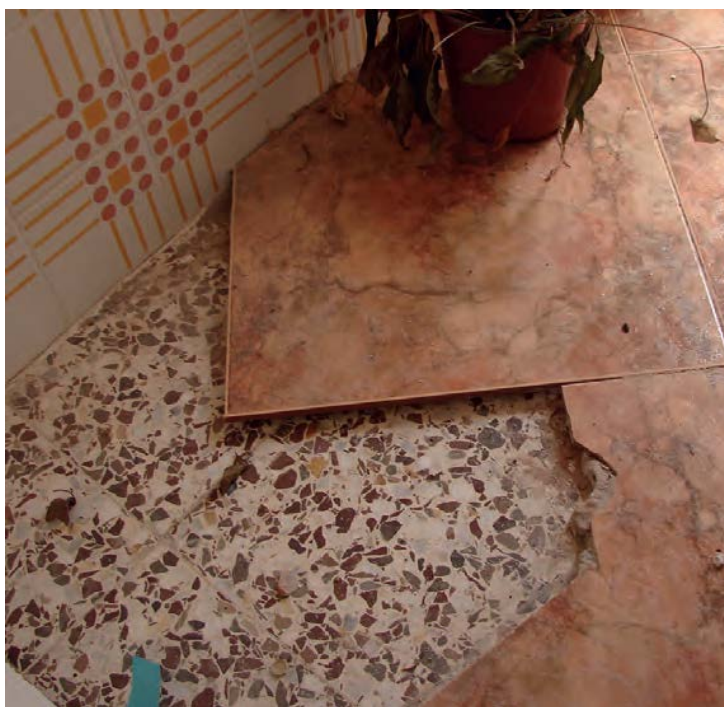
▲ Photograph 7-14

Yet another factor worthy of note was the effect of the very thick flooring on floor slabs due to the routine practice of re-flooring without removing the previous layer (Photograph 7-14). Curiously, one of the most common post-quake repair measures consisted of laying new floors over the existing material.

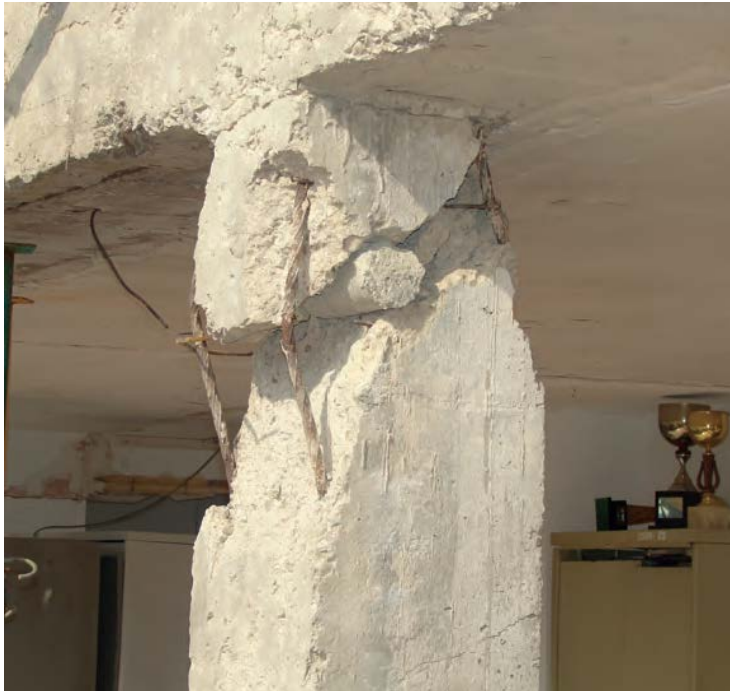
▲ Photograph 8-10

Sufficient importance is not always attached to this problem. Note the trajectory of the column failure in Photograph 8-10³, which was indisputably conditioned by the position of the mortar used to fill a core hole.
