The Lorca Earthquake

Effects on buildings

INTEMAC

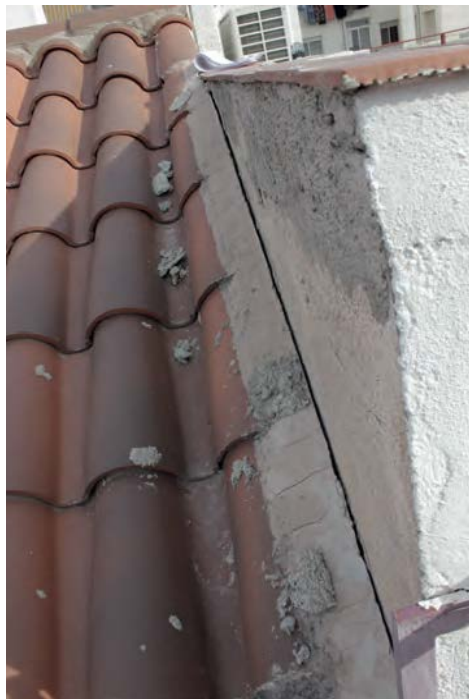
▲ Photograph 1-10

In most cases no real joint is visible between the party wall buildings. The separation generally consists of polystyrene panelling (Photograph 1-9), which in the most recent buildings is sealed with silicone along the façade. At roof level, however, the joints are sealed with mortar to prevent leaking (Photograph 1-10).

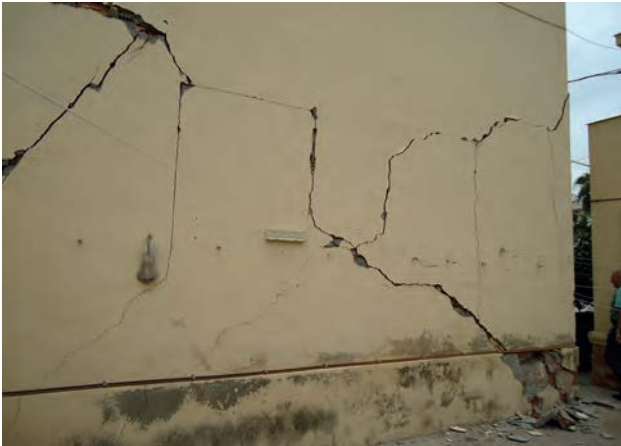
▲ Photograph 1-12

The construction quality in these cases is generally poor. The materials used are inappropriate and laid to no bond or pattern and the general form is scantily suited to resist horizontal action. Moreover, given their age, these are the buildings that have undergone the most intense and often misguided remodeling. Cracking in some walls revealed that new openings had been made, former openings walled up (Photograph 1-12) or enlargements built with little or no regard for the existing structure.

Likewise due to their older age, these are the buildings where weathering-induced deterioration is most intense. Capillary moisture rising from the ground (clearly visible in Photograph 1-12 above), damp at the floor-wall abutment (where, moreover, problems due to insufficient support length -Photograph 1-13- or insect infestation are frequently observed) and want of satisfactory maintenance are the reasons for the less than optimal state of conservation of many of these buildings.

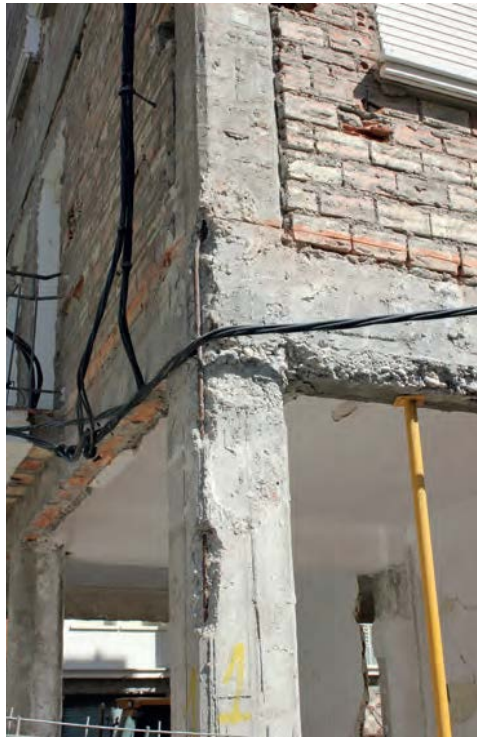
▲ Photograph 1-17

The soundness of these masonry in-fills may very likely have contributed to the earthquake resistance of buildings whose carelessly built structure, consisting of materials (smooth, inappropriately positioned reinforcing bars and concrete prepared in situ without the necessary control, Photograph 1-17) of questionable quality, does not in most cases meet the minimum standards of performance laid down in today's codes and regulations.

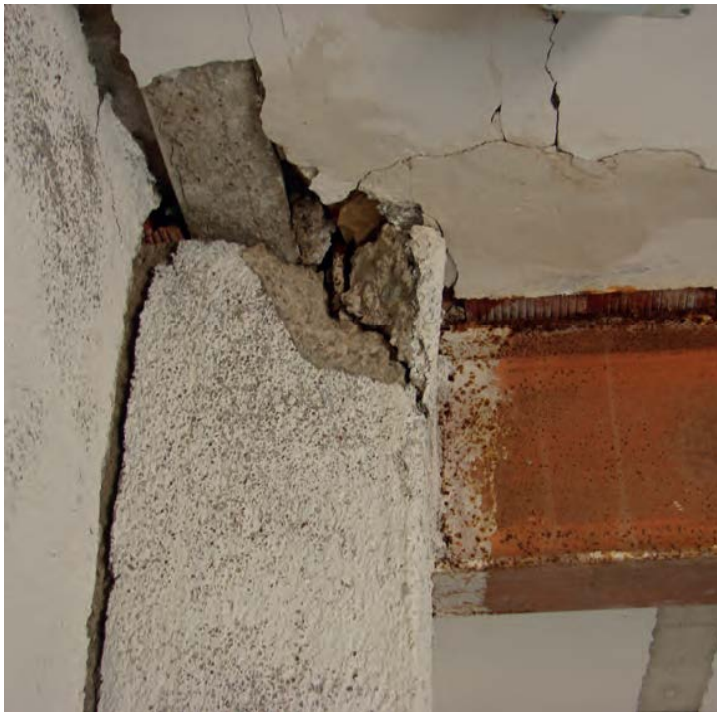
▲ Photograph 1-18

In a few years higher rise buildings were being built, with longer beam and floor slab spans and new construction systems. One of these consisted of the use of mixed solutions: steel beams resting on reinforced concrete columns (Photograph 1-18).

Today this solution is known to be wholly unsuitable, but it was used fairly profusely at the time. Such systems in fact account for a non-negligible portion of all the structural types identified (Figure 1-5).

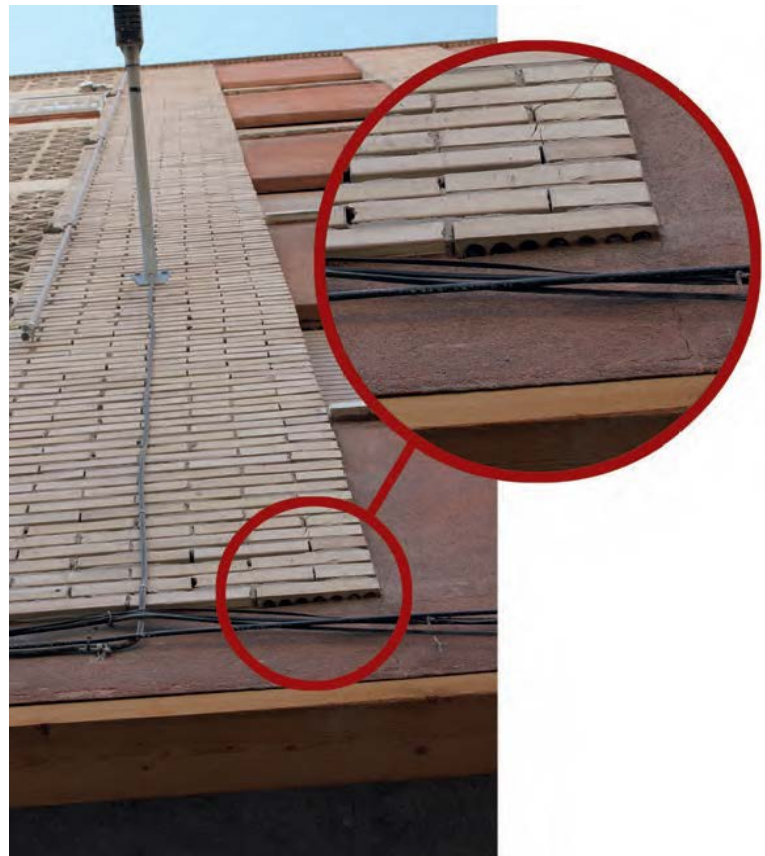
▲ Photograph 1-19

The façades in such buildings rest only partially on the slabs (Photograph 1-19) and rise to form parapets around the (nearly always flat) roofs.

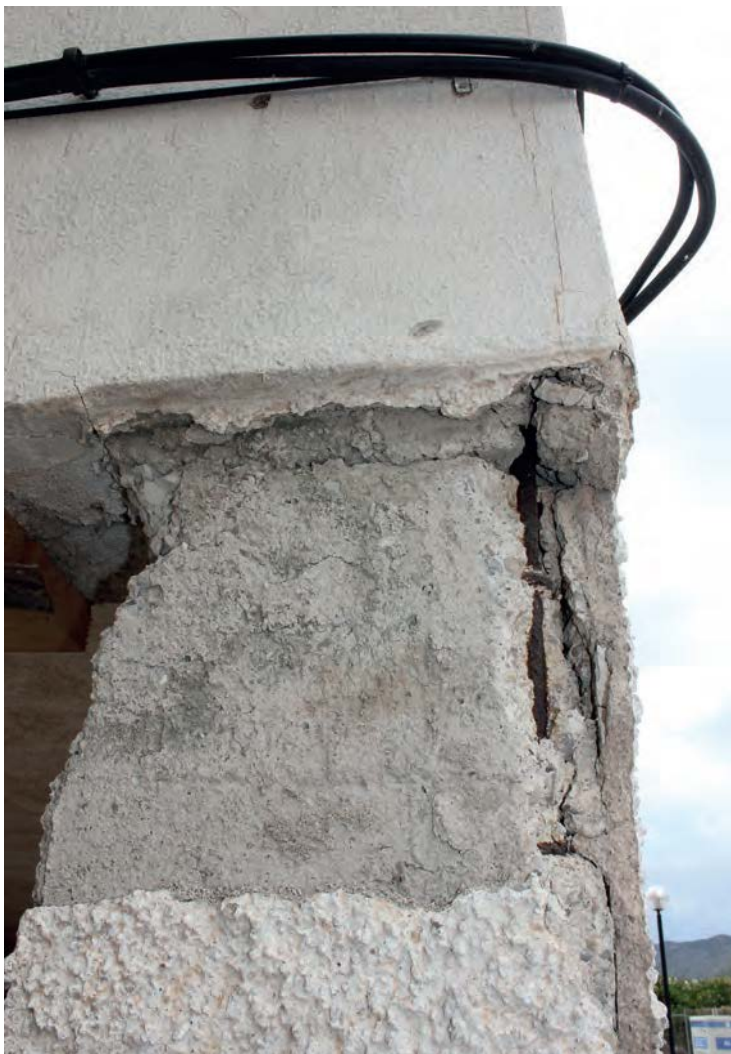
▲ Photograph 1-20

The top of the column in Photograph 1-20 obviously looks different after the quake than it did before, but it is equally obvious that the tremor only caused the collapse of material that had already loosened. Consequently, the structure is no less safe after than before the earthquake.

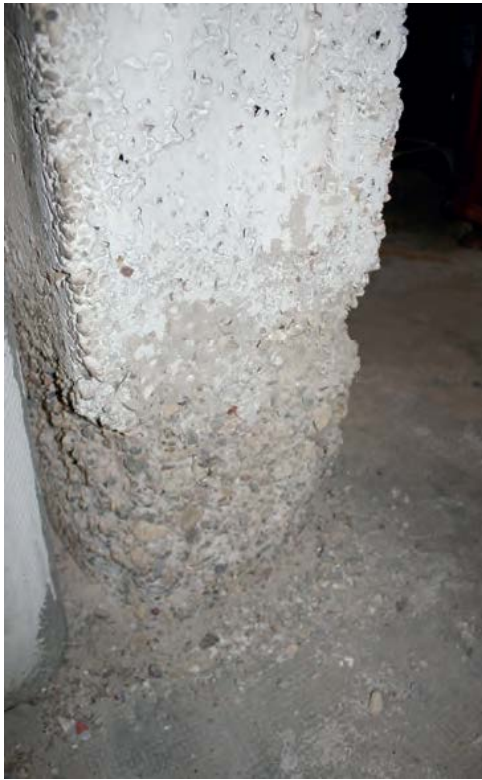
▲ Photograph 1-21

Similarly, the earliest surveys revealed another widespread problem, deterioration at the bottom of the columns and walls due to capillary moisture from the soil.

Many columns were found to look like the one depicted in Photograph 1-21.

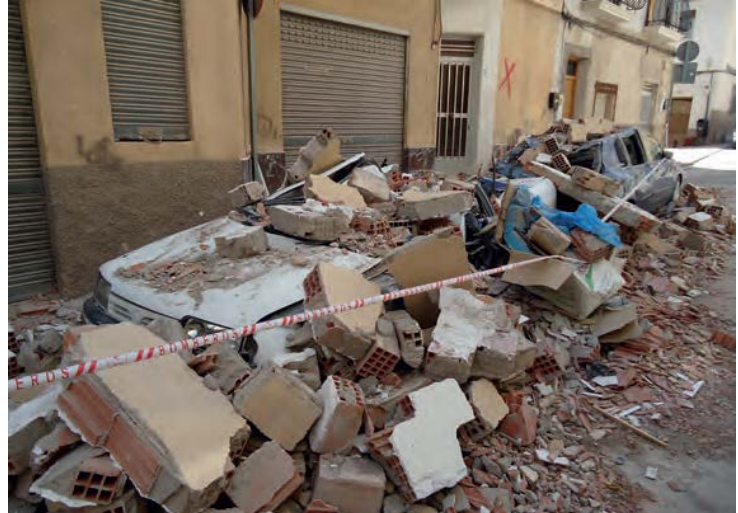
▲ Photograph 2-1

Many of the streets in Lorca looked like the one depicted in Photograph 2-1. Sidewalks, automobiles and roadways were littered with masonry rubble, the occasional whole section of façade or parapet and all manner of debris. Although this litter was found in all the city's quarters regardless of location, it was particularly abundant in areas with a prevalence of modern buildings, understood to mean the ones whose structure is separate from the enclosure, as opposed to older, bearing wall buildings.

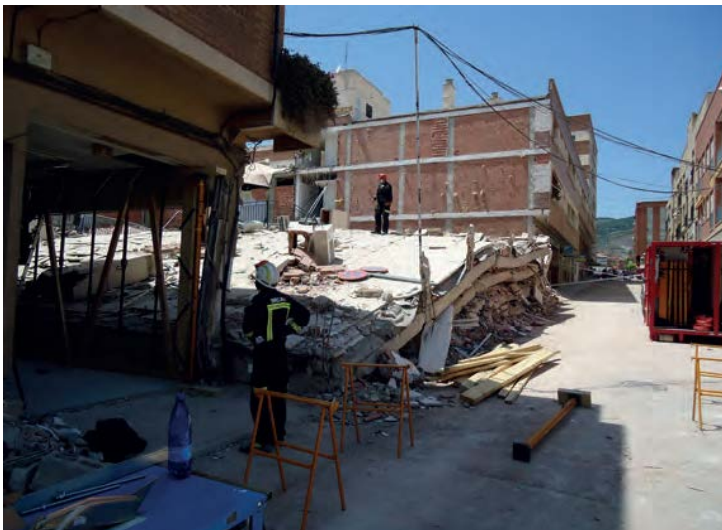
▲ Photograph 2-2

from historical structures, only one building collapsed entirely (Photograph 2-2), although several collapsed partially (Photograph 2-3).

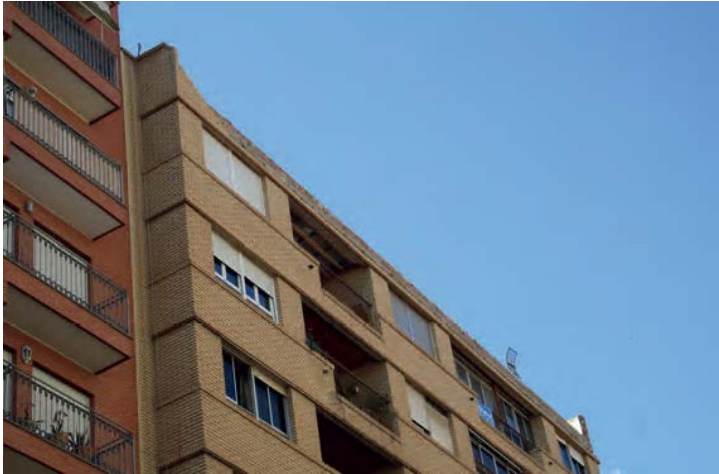
▲ Photograph 2-4

Observation of the buildings involved led to the conclusion that architectural elements collapsed due essentially to two mechanisms. Roof parapets (Photograph 2-4) and, to a lesser extent, some sections of enclosures, primarily on the upper storeys, seemed to have collapsed under loads normal to their plane, i.e., inertial bending moments that the bearing on the floor slab (the sole strength mechanism in the case of the parapets) was unable to absorb.

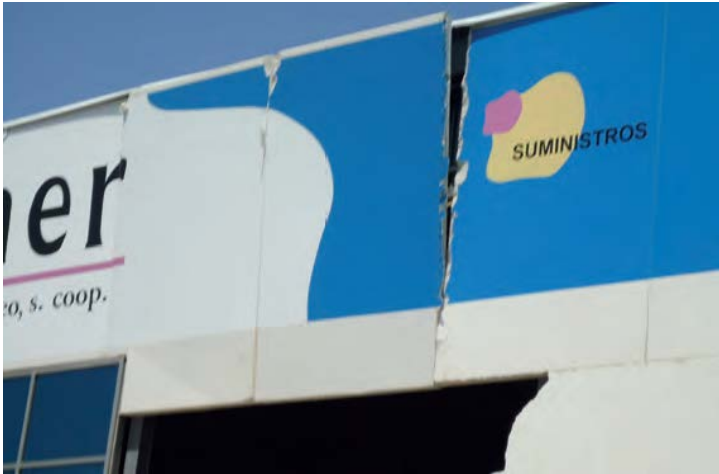
▲ Photograph 2-5

This problem appeared in many conventional masonry façades, but also in pre-cast enclosures on some of the industrial bays (Photograph 2-5).

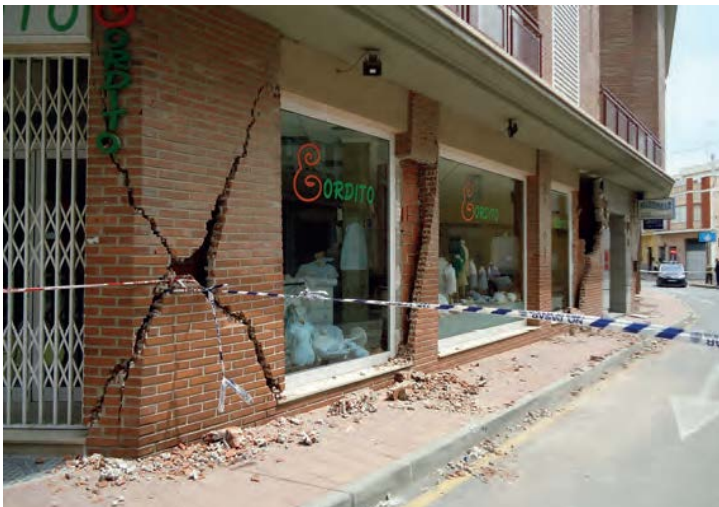
▲ Photograph 2-6

Lower façade failure followed a different pattern, consistent with collapse due to in-plane action originating at the edge. Such actions induce the characteristic “X”-shaped crevices (Photograph 2-6) observed in many of the town’s buildings.

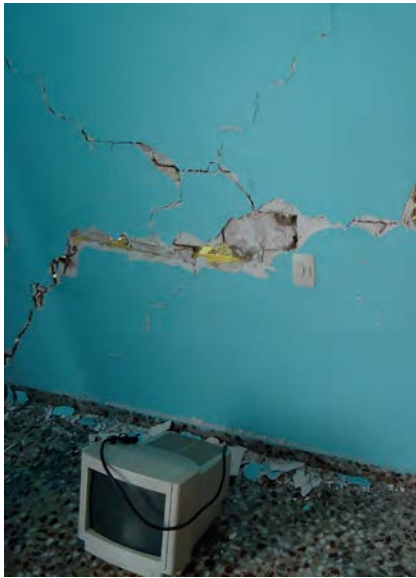
▲ Photograph 2-7

Subsequent indoor surveys revealed the same damage pattern in both the main (around community areas) and secondary partition walls (Photograph 2-7). Here the “X”- shape was not always as clear as in the enclosures because the cracks tended to follow along the cableways and other conduits built into the walls.

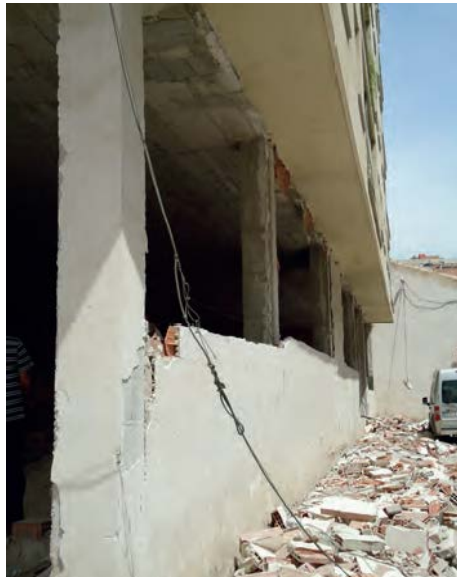
▲ Photograph 2-8

Many of the provisional ground storey enclosures around store fronts in the more recent buildings also collapsed. Most consisted of very slender masonry infills (Photograph 2-8) ineffectively anchored to the structure and carelessly built.

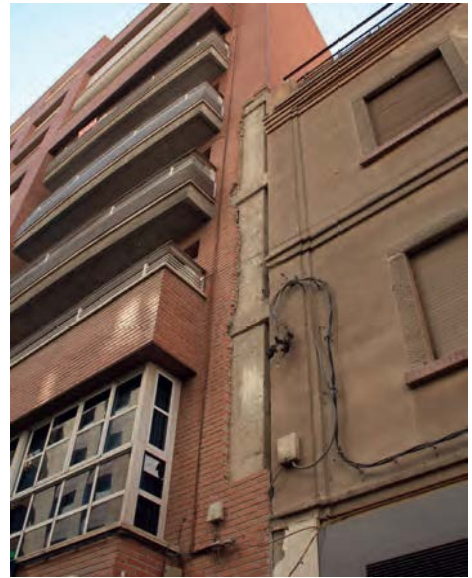
▲ Photograph 2-9

This type of failure due to in-plane action also affected the wall sections closest to an adjacent building, where the full impact of pounding was felt (Photograph 2-9). This was particularly (although not exclusively) visible in buildings with storey divisions at different heights.

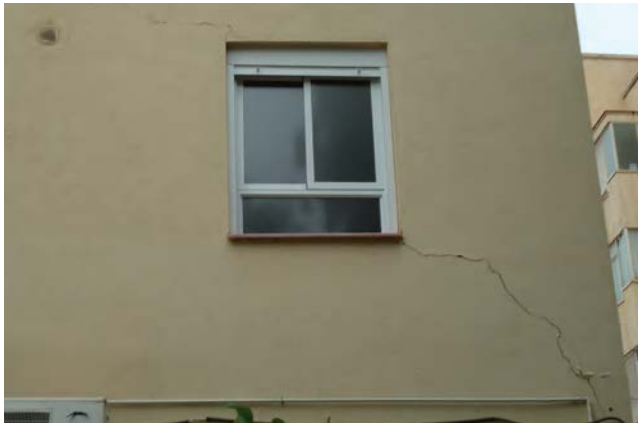
▲ Photograph 2-12

Slanted cracks of variable widths were observed in many surfaces, often stretching between openings in wall sections (Photograph 2-12).

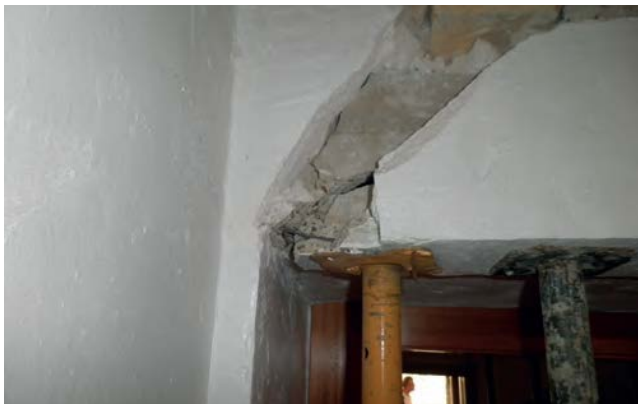
▲ Photograph 2-13

Subsequent surveys revealed other types of indoor damage, frequently associated with remodelling undertaken with little regard for the original structure. One consequence, shown in Photograph 2-13, is lintel failure.

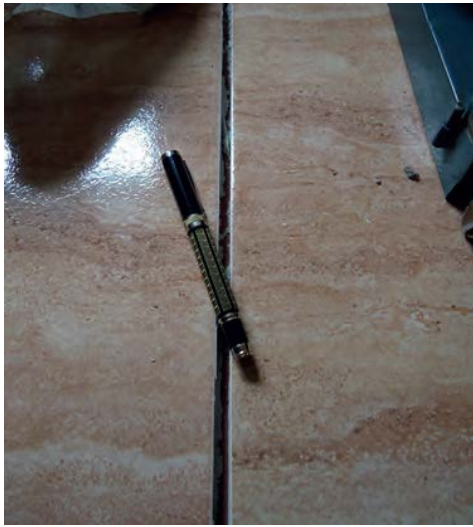
▲ Photograph 2-14

In some floors, joints were observed to widen along the separation between slab elements (Photograph 2-14), normally precast reinforced or prestressed concrete joists with any of a wide variety of inter-joist fillings. These slabs had no topping.

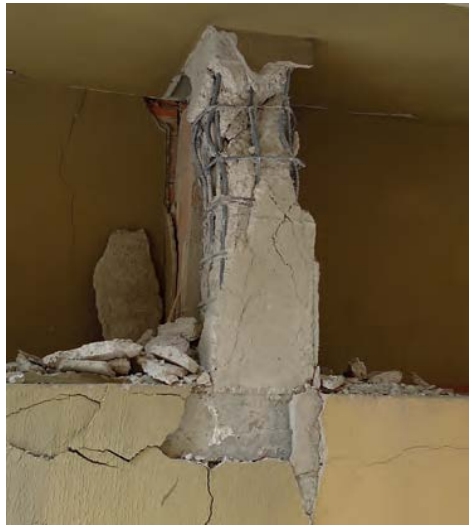
▲ Photograph 2-15

In the initial surveys, the most obvious damage observed in reinforced concrete buildings was associated with short columns (Photograph 2-15). Entire lines of façade columns, all short, collapsed in several buildings.

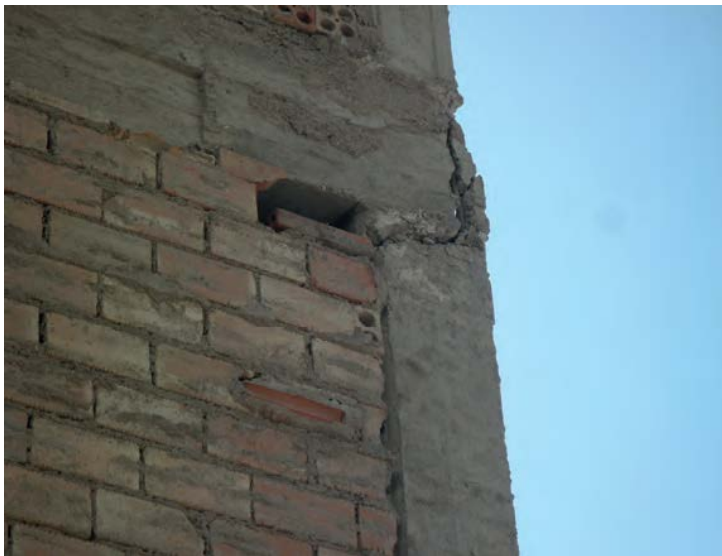
▲ Photograph 2-16

Severe column damage was also observed, generally on the ground storeys, attributable to the interaction between the structure and the masonry fillings (Photograph 2-16). In other cases the damage was due to pounding between adjacent buildings, especially where the floor slabs in the buildings involved were at different heights.

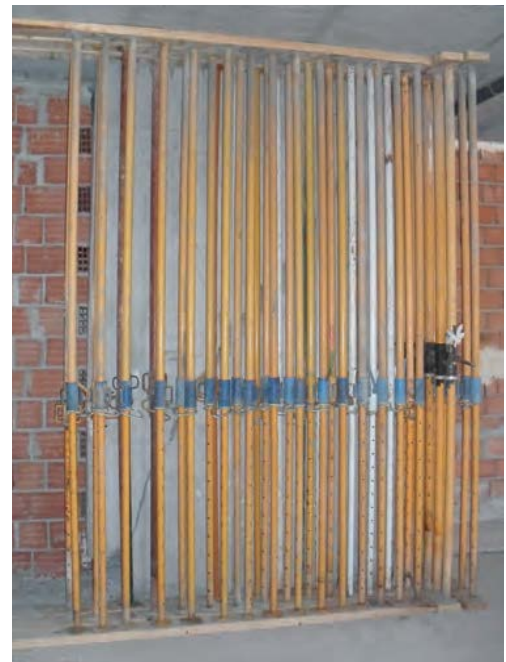
▲ Photograph 2-17

Other types of failure, such as in some unsuitably reinforced shear walls (Photograph 2-17) or in stairwell enclosures and slabs, appeared in subsequent more detailed surveys of the buildings.

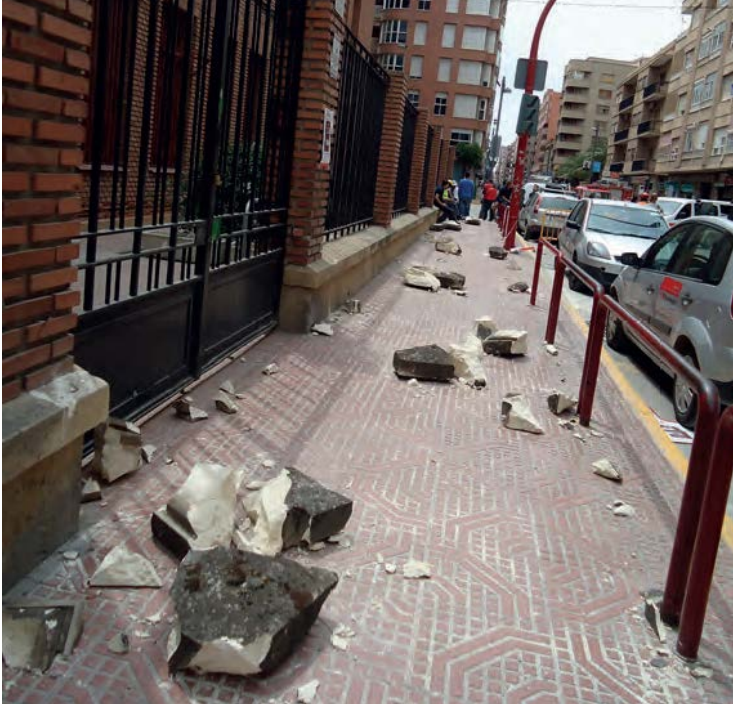
▲ Photograph 3-1

This idea is illustrated in Photograph 3-1. All the top pieces on the masonry pilasters fell to the ground. The inference is that the stress generated between

these blocks of stone and the pilasters on which they rested was stronger than friction and the mortar bond together (this would have been highly unlikely if the blocks had rested on the ground, in which case friction alone would have sufficed to absorb the horizontal force amounting to 36 % of its weight, the peak ground acceleration reached during the quake). In this same vein, once the bond was broken, the relative displacement between the blocks and the pilasters must have greatly exceeded the 3 centimetres recorded at ground level.

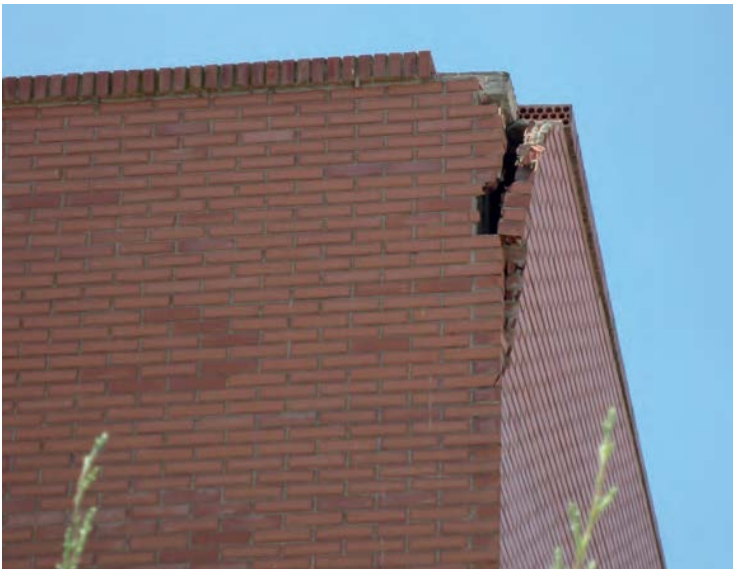
▲ Photograph 3-2

The IGC report [49] describes even more spectacular examples. The dome on Nuestra Señora del Rosario Chapel became detached from the walls on which it rested after shifting by around 15 cm. A less striking but equally illustrative example is given in Photograph 3-2: a façade which at the top may well have exceeded the aforementioned values.

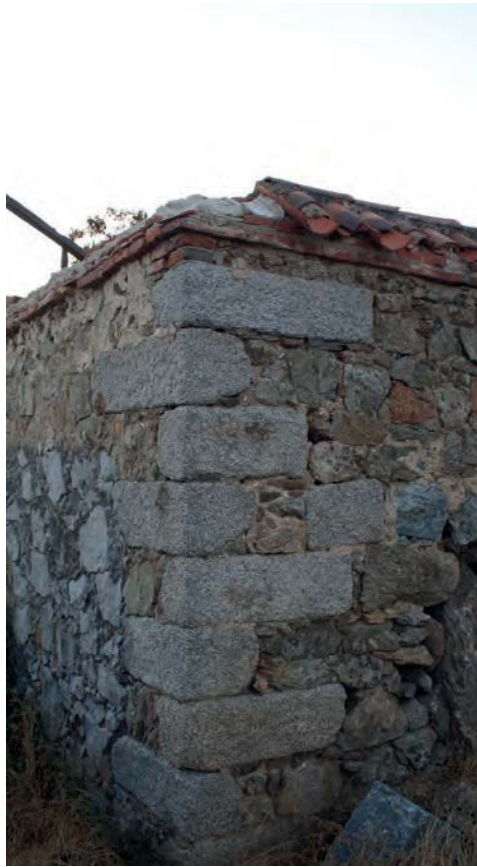
▲ Photograph 4-1

That concentration of stresses at the corner connection justifies the care traditionally placed in its construction. In traditional bearing wall construction, this was achieved (even in walls subject to scant stress, such as the boundary marker shown in Photograph 4-1) by alternating ashlar headers and stretchers at the joint between walls made of poorer quality materials.

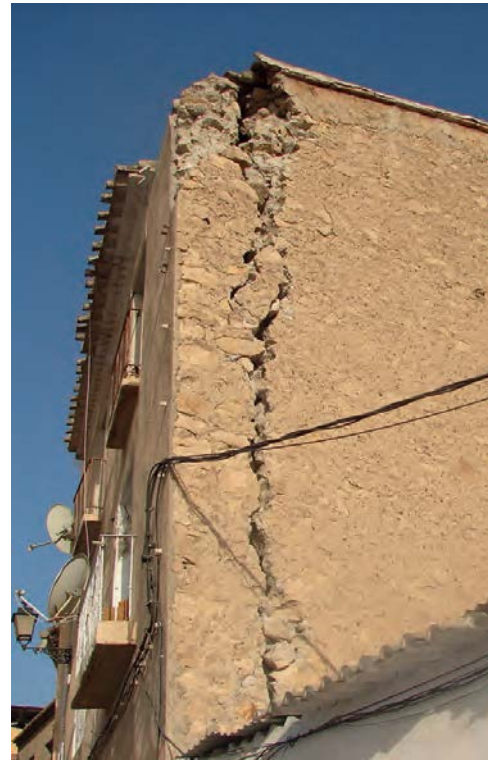
▲ Photograph 4-2

At Lorca, these traditional construction principles were often ignored, and as a result the walls pulled apart as in Photograph 4-2, which depicts a type of failure commonly observed at this site.

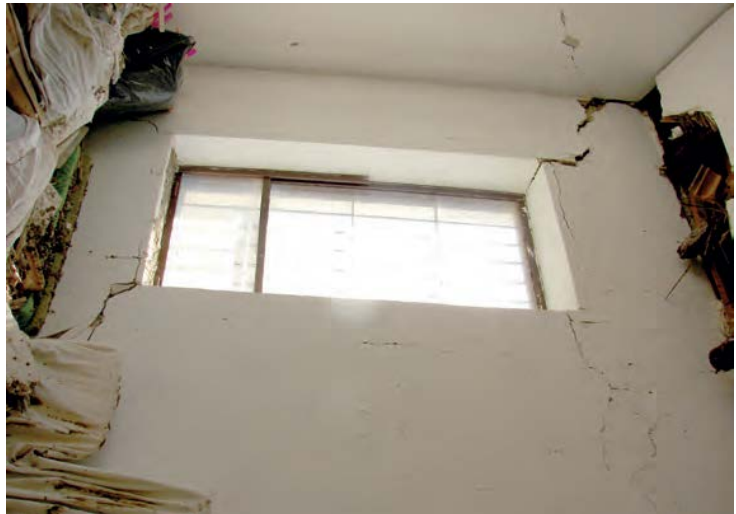
▲ Photograph 4-3

While structural walls can be made of poor quality masonry, even coarse rubble, when greater stability is required restraint mechanisms must be provided (traditional lacing courses). These afford a mechanical solution for inter-wall abutments (alternating headers and stretchers) or to strengthen openings where the stress that inevitably concentrates at the corners can only be absorbed by careful bonding. The consequences of neglecting this requirement are illustrated in Photograph 4-3.

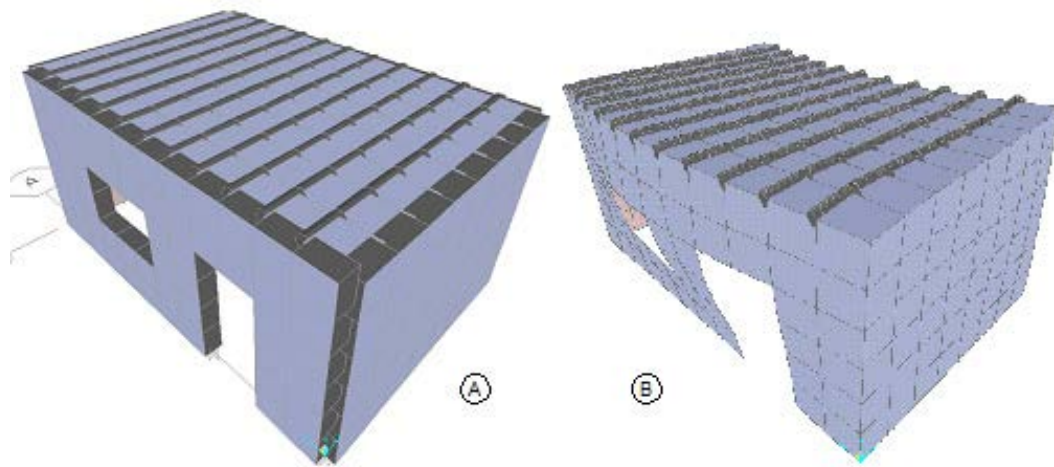
▲ Figure 4-4

For this system to be effective the floors must be monolithic, i.e., with sufficient in-plane stiffness and strength to act as an effective diaphragm. Only then can they perform like deep beams able to resist bending forces, receiving and transferring inertial forces to the bracing walls on which the beam rests (Figure 4-4).

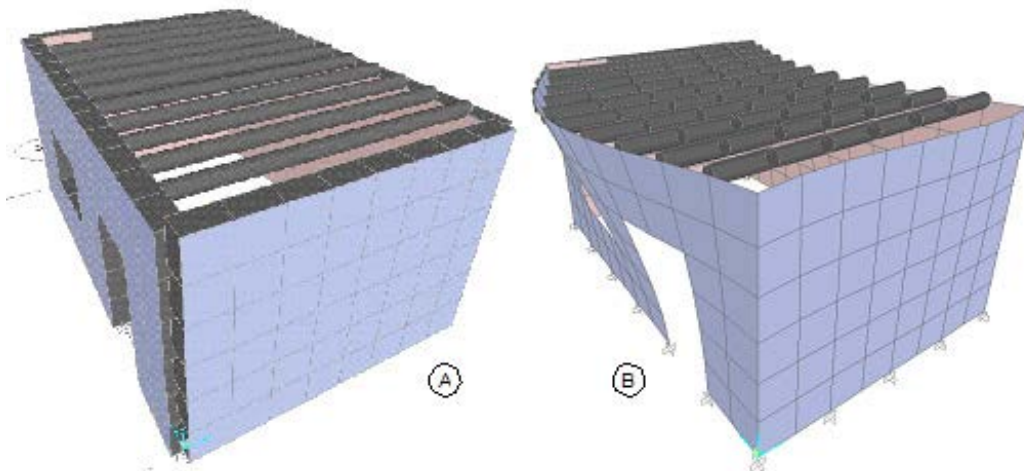
▲ Figure 4-5

In the best of cases, simulated with the numerical model depicted in Figure 4-5 A, the joists (all the ceilings observed in wall structures had them) merely joined the tops of similarly stiff sections of wall. In that case, the two sections move simultaneously and in the same direction, with neither actually restraining the other in any way whatsoever (Figure 4-5 B) In other words, the ceiling fails to fulfil its purpose as a brace, but at least the joists bear no loads.

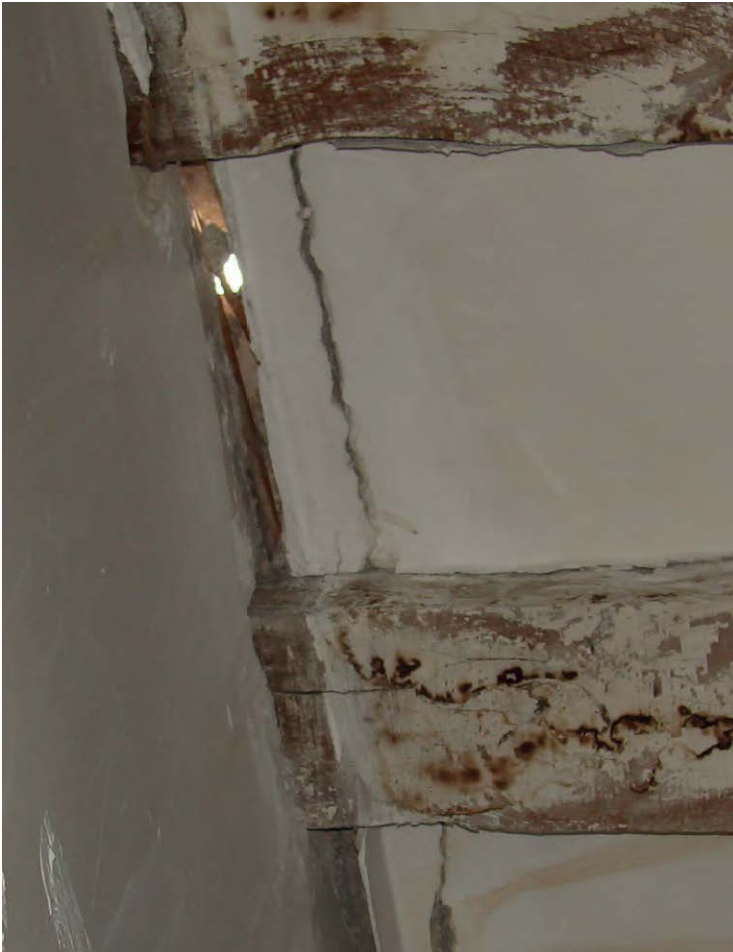
▲ Photograph 4-4

Where the joists join walls with different stiffness values, the problem is more severe, because in that case the two walls move in different directions (the stiffer attempts to bear up the more flexible), inducing membrane stress on the floor. Since the wall-joist connection is unable to bear any tensile stress so generated, the joists slip at the abutment (Photograph 4-4).

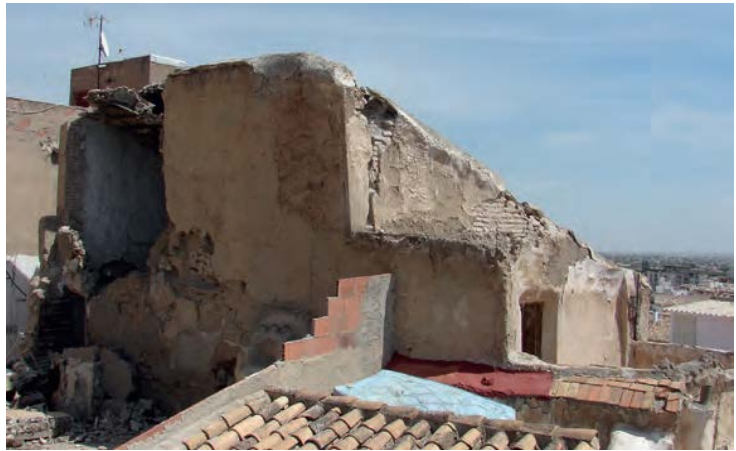
▲ Photograph 4-5

Some of these problems are reflected in Photograph 4-5.

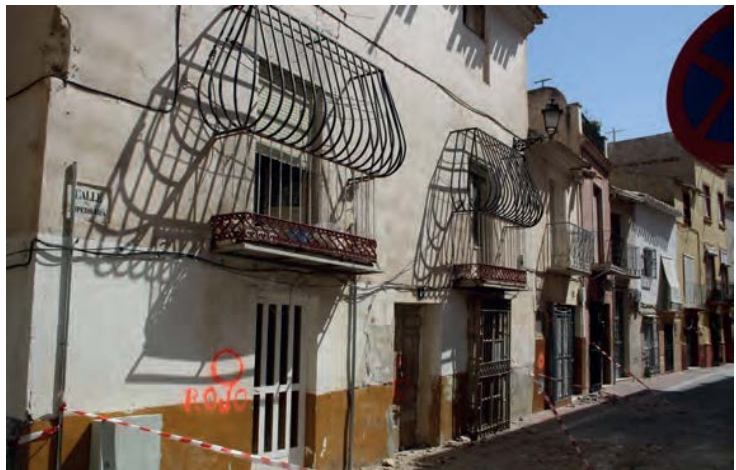
▲ Photograph 4-6

The basic earthquake-resistant unit was not, in many cases, the building, but the city block (Photograph 4-6).

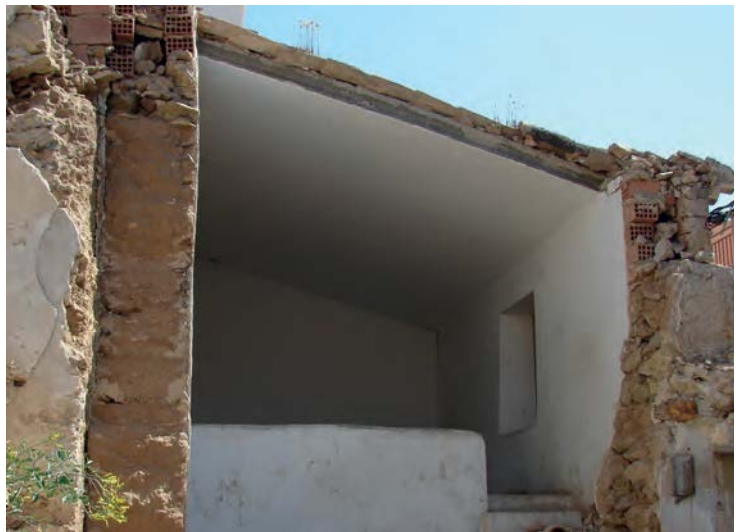
▲ Photograph 4-7

Another common practice was to mix different materials in a given structural unit (Photograph 4-7), probably as a result of building enlargements.

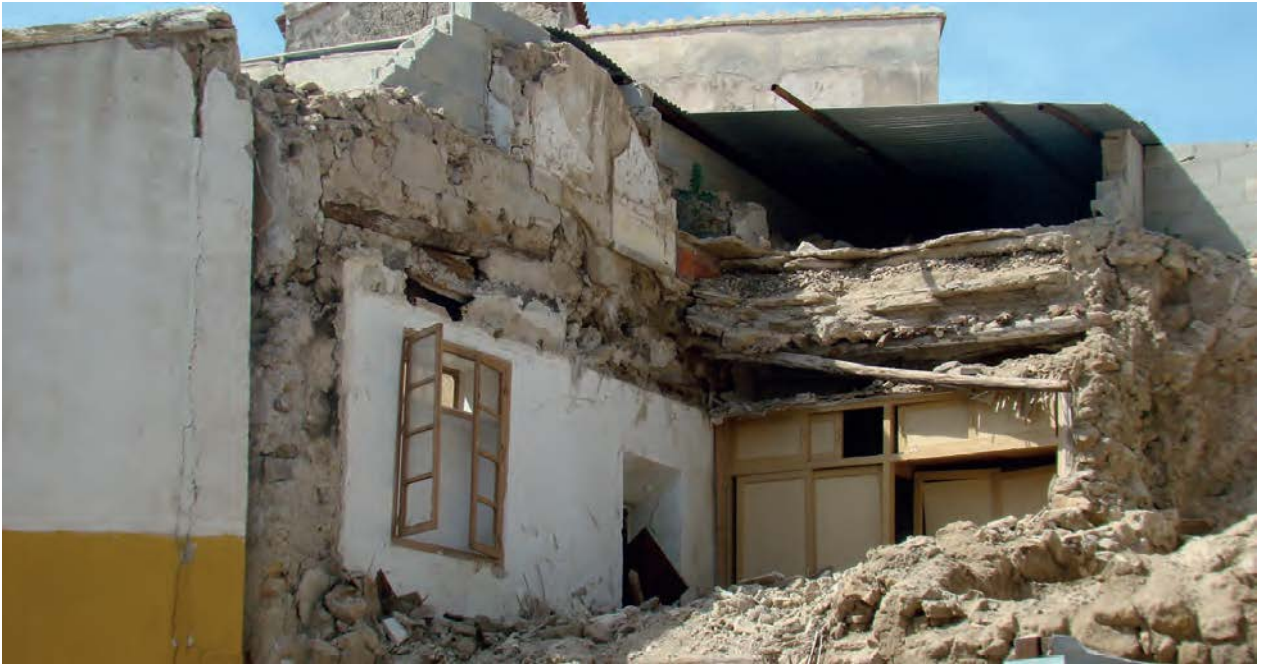
▲ Photograph 4-8

Timber creep generates long-term deflection in traditional floors. That effect was often countered by adding fillers whose weight induced further deflection, subsequently corrected by adding more filler and so on until the situation reached the extremes illustrated in Photograph 4-8.

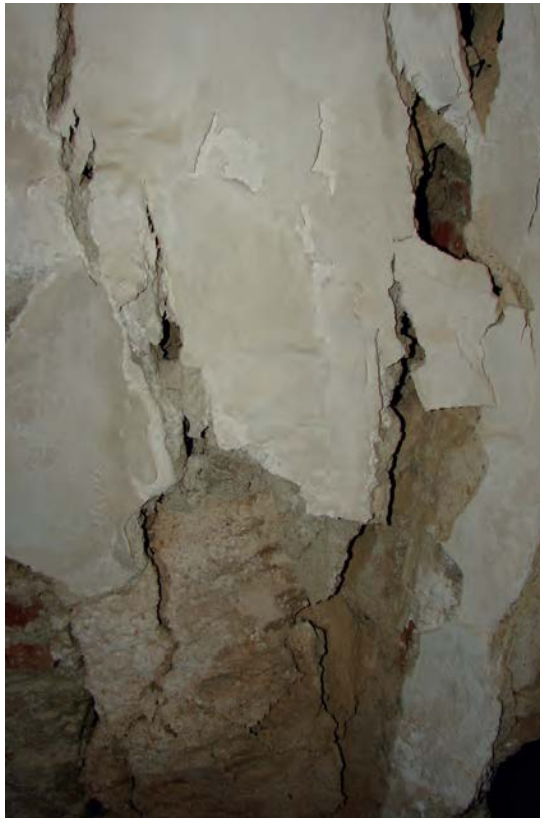
▲ Photograph 4-9

There we found “*thick walls*” literally shattered (Photograph 4-9) due to poor workmanship, deteriorated and inappropriate materials or the absence of protection against the elements. We also saw large, sturdy beams that failed for insufficient support length, moisture or insect-induced deterioration, or similar.

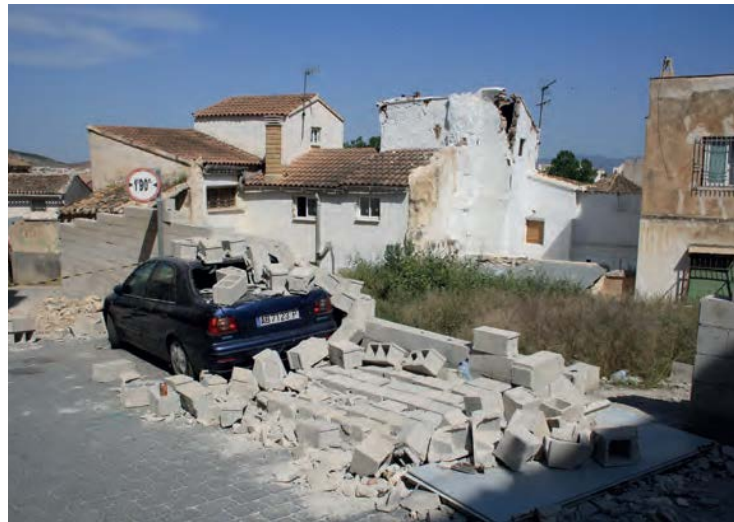
▲ Photograph 5-1

For a masonry element resting on the ground the major effect of the Lorca earthquake would therefore be a lateral force equivalent to 36 % of its weight (Figure 5-3). When the height of such a wall is over a certain value, the moment at the base obviously exceeds its bending capacity, inducing collapse (Photograph 5-1).

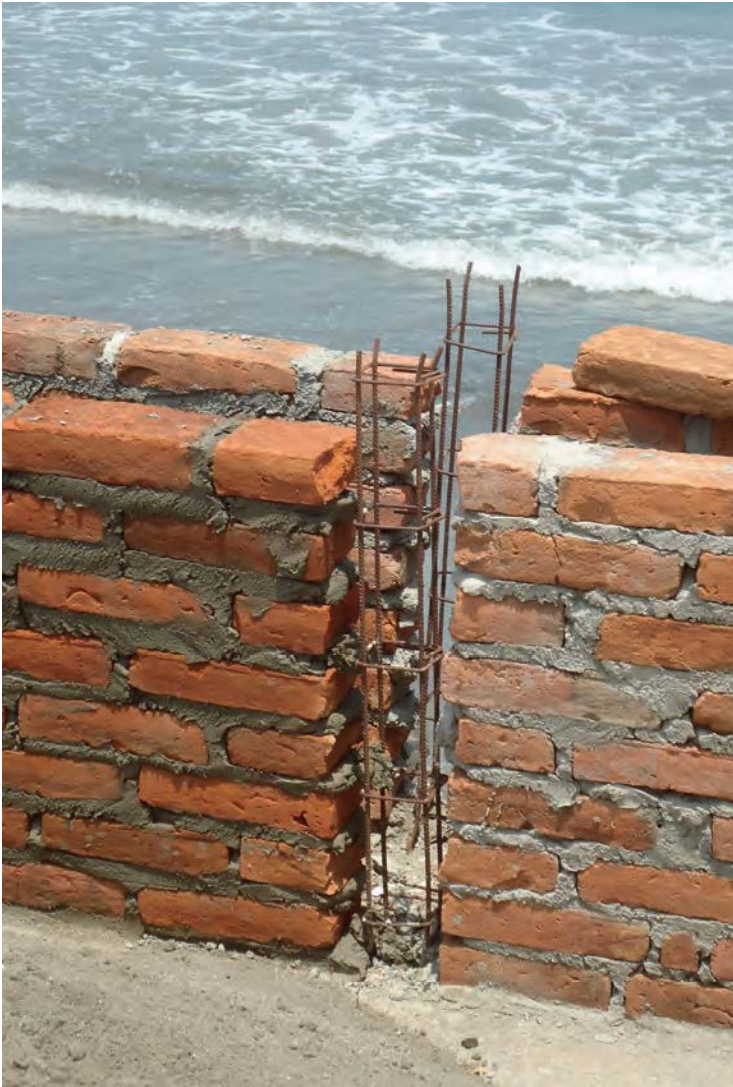
▲ Photograph 5-2

These factors are addressed more thoroughly in other legislations. Photograph 5-2, taken on the Atlantic coast of Mexico, a moderately seismic zone, depicts the construction of a masonry parapet less than one metre high. Note the use (systematic in the region) of reinforced concrete columns spaced at short intervals.

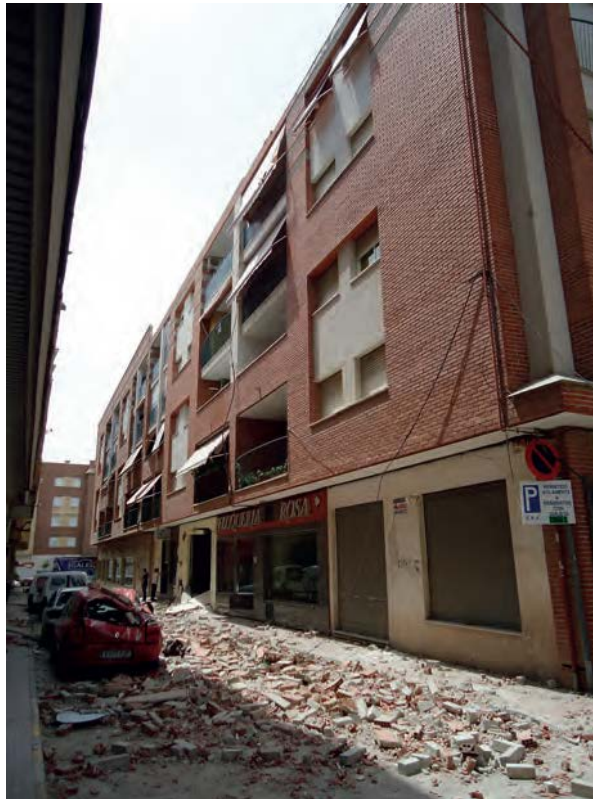
▲ Photograph 5-3

A regularly shaped, five-storey building (representative of many buildings in the city, Photograph 5-3), whose structure consists of flat reinforced concrete portal frames spaced at 5 m, forming four bays for a total width of 16 m, was modelled to determine the acceleration affecting the infills on each storey. The storeys in the shear portal frame model used were all 2.75 m high, except the ground storey, which measured 3.5 m. The masses were estimated in keeping with standard construction practice and the building codes normally applied.

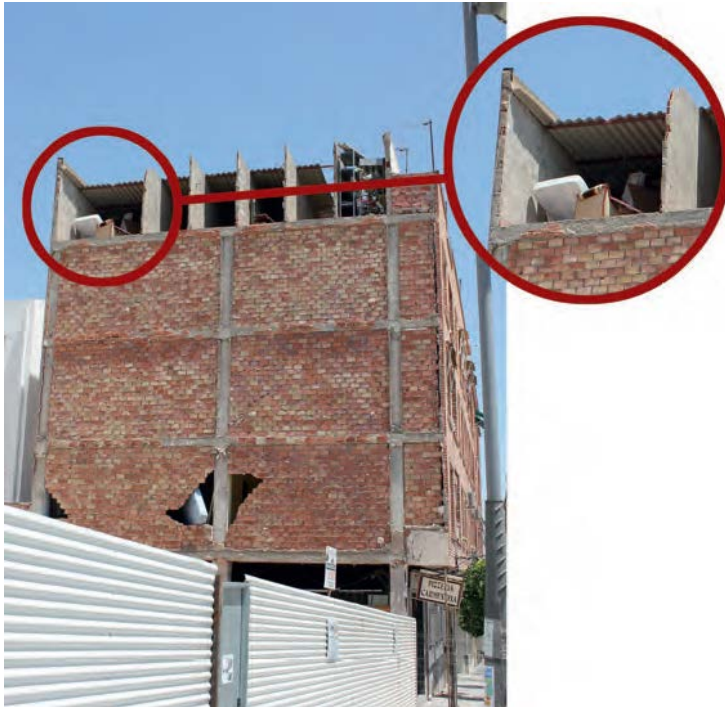
▲ Photograph 5-4

The existence of more flexible members than parapets, such as bulkheads or roof enclosures consisting at times of very slender walls (Photograph 5-4), complicates matters.

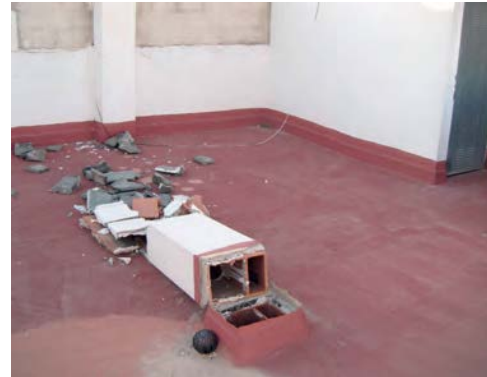
▲ Photograph 5-5

All the foregoing on masonry walls can naturally be applied to the rest of the roof elements, such as chimneys (Photograph 5-5), bulkheads and antennas.

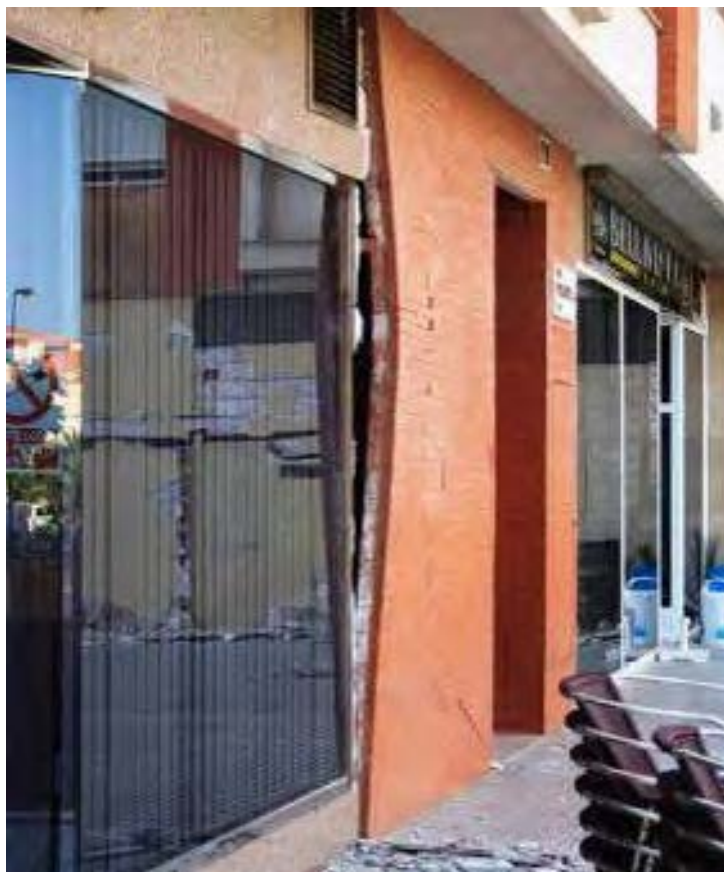
▲ Photograph 5-6

Such values are negligible compared to the loads induced by the earthquake (which is why they were disregarded in the preceding calculations). In infills, by contrast, the vertical loads are much greater because in addition to their own weight they bear part of the heavier loads acting on the floor slabs. This effect is greatest in standard flat portal frames positioned parallel to the façade and supporting one-way slabs. While the values are not overly high, their contribution would always be more significant in upper storey infills than in parapets. In the lower storeys, on the contrary, the accumulation of gravity loads transferred downward across the enclosures could explain the buckling observed in some infills

exposed to earthquake-induced lateral action (Photograph 5-6).

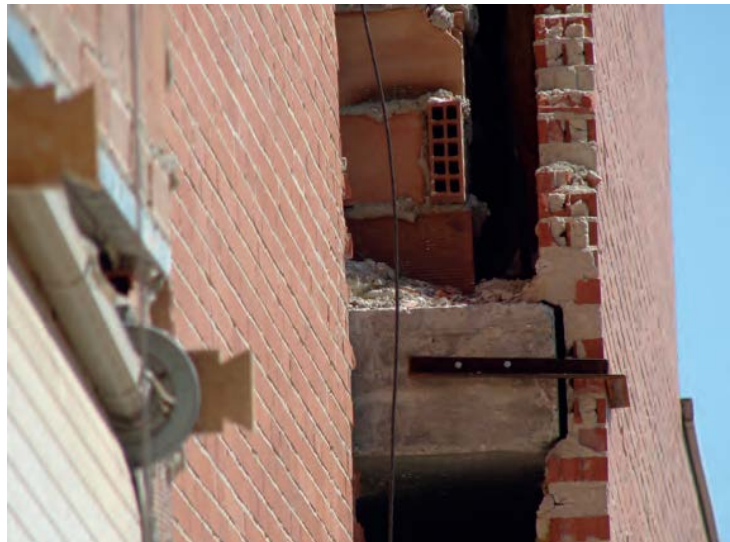
▲ Photograph 5-7

- Consequently, the model would only be applicable in the areas of the infills adjacent to the columns (which would act like arch ties). In practice, the greatest problem is that it is impossible to ensure that even 2/3 of the infill actually rests on the slabs (Photograph 5-7).

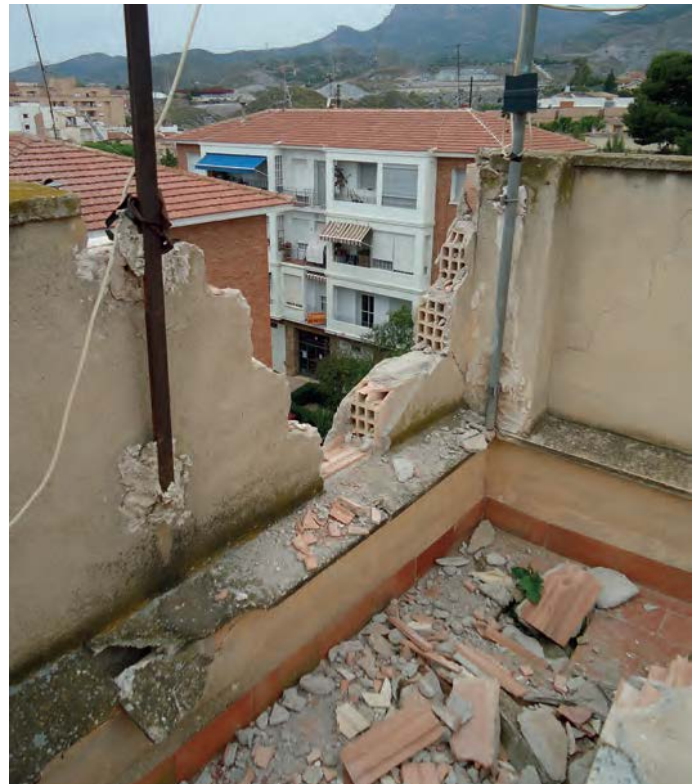
▲ Photograph 5-9

At other times the lack of joints to absorb masonry deformation induces vertical cracking that interrupts the continuity of the wall, countering the beneficial effect of the pilasters. Note the cracking on the wall to the right of the corner in Photograph 5-9 (the adjacent wall also foreseeably cracked prior to collapse).

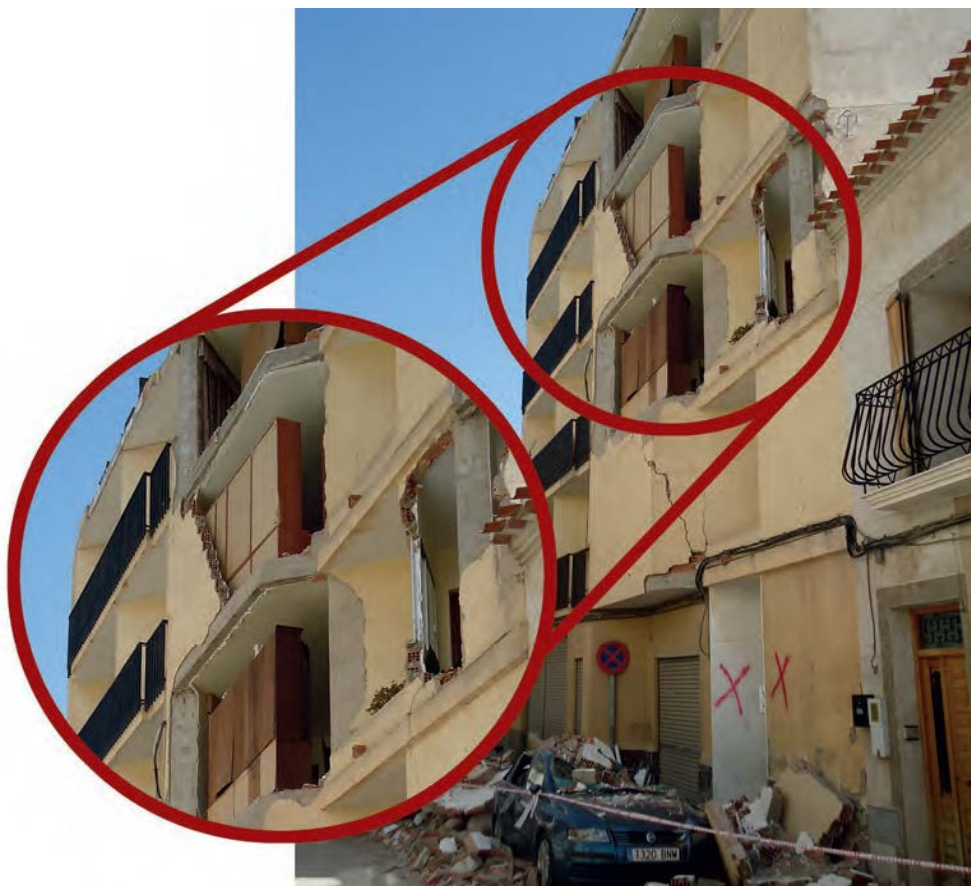
▲ Photograph 5-10

That means that on the slab with the greatest recess from its design position (Figure 5-17, the bearing under the wall would be $(8.5 - 2 \cdot \Delta)$, where “ Δ ” is the allowable deviation according to the applicable tolerance table. Given that such deviation varies in the existing structural concrete code from 2.4 to 5 cm for conventional buildings, the obvious inference is that even in correctly constructed buildings, some of the infills may be wholly unsupported.

A clear example is shown in Photograph 5-10, which depicts intermediate storeys
