The Lorca Earthquake

Effects on buildings

INTEMAC

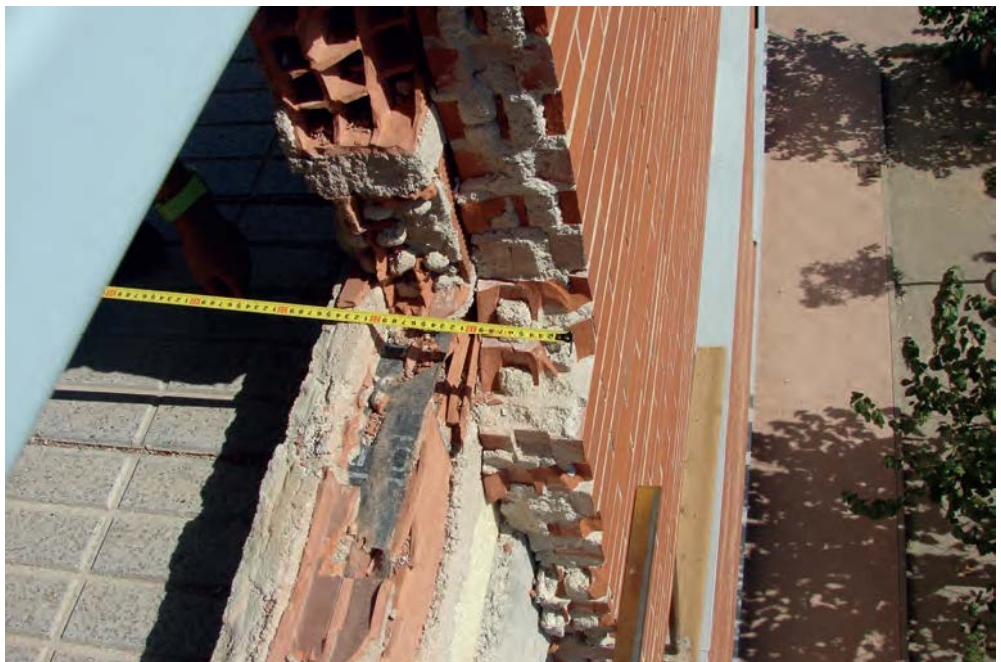
▲ Photograph 5-12

Another example of these problems is illustrated in Photograph 5-12: the outer wythe was laid in front of the floor slab, leaving only the inner wythe to rest correctly on the slab. The weatherproofing installed across the entire thickness of the latter prevented any satisfactory bearing, however.

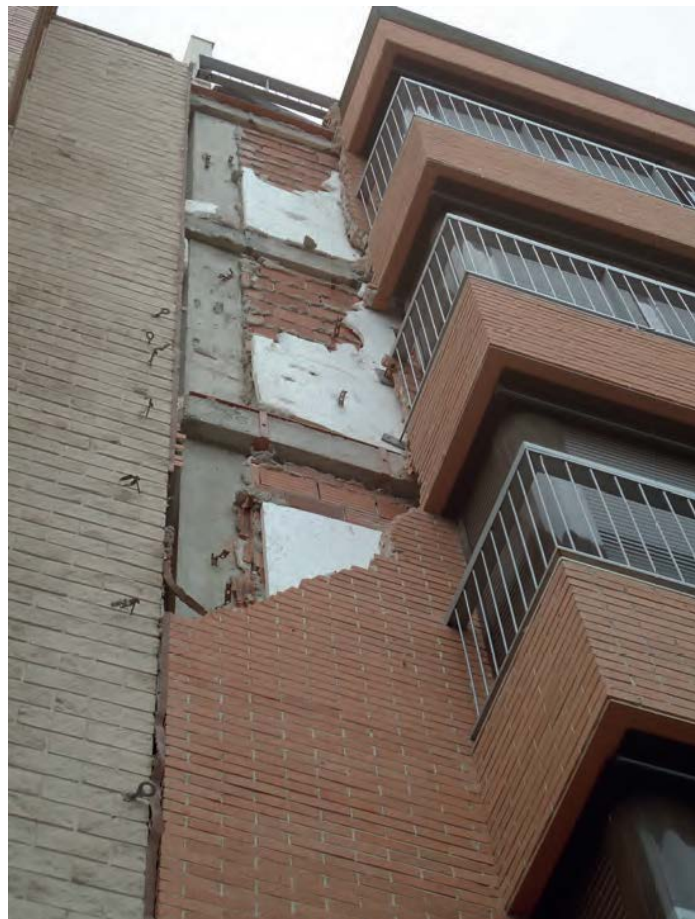
▲ Photograph 5-13

Pounding between adjacent buildings (Photograph 5-13) during earthquakes generates in-plane forces in the masonry walls, inducing failure different from the type discussed in the preceding items. The problem is nonetheless addressed in this chapter because its consequences are similarly severe. Moreover, in some cases at least, drift in buildings perpendicular to the common façade plane also generates forces normal to the masonry walls for, while in theory the separation joint between them should prevent that happening, in practice many such joints are mortar-filled, maintaining continuity even in the face of this type of actions.

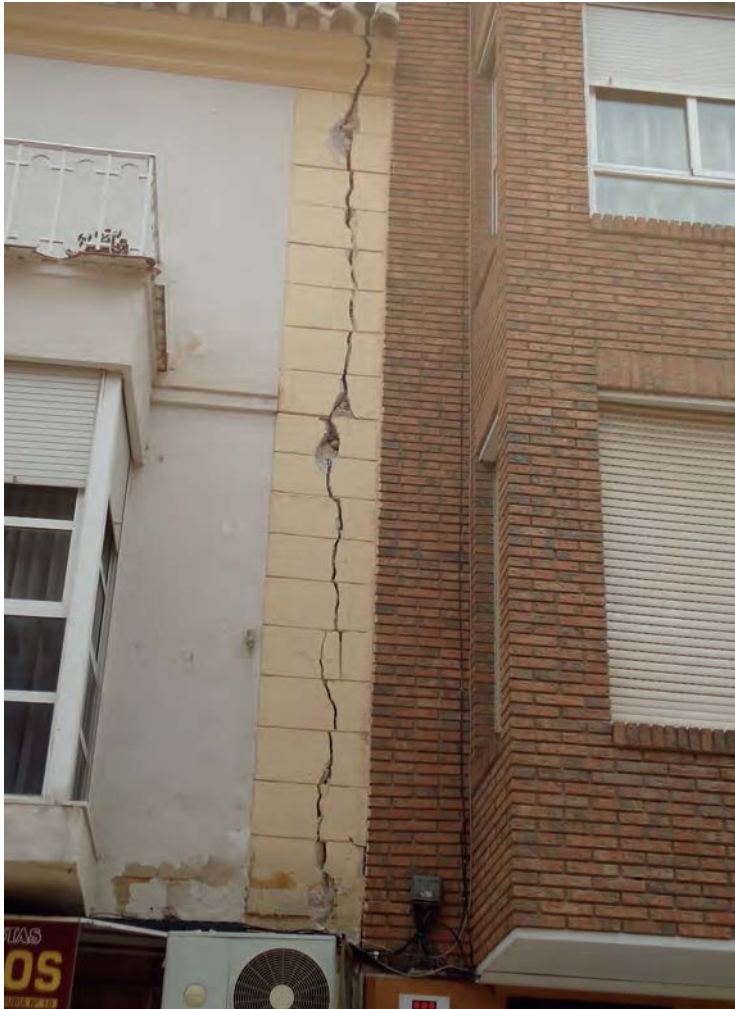
▲ Photograph 5-14

Standard practice at Lorca appears to have been to abut adjacent façades and even press mortar into any gaps between them. It should come as no surprise, then, that on occasion the quake created new joints positioned off the theoretical separation between buildings (Photograph 5-14).

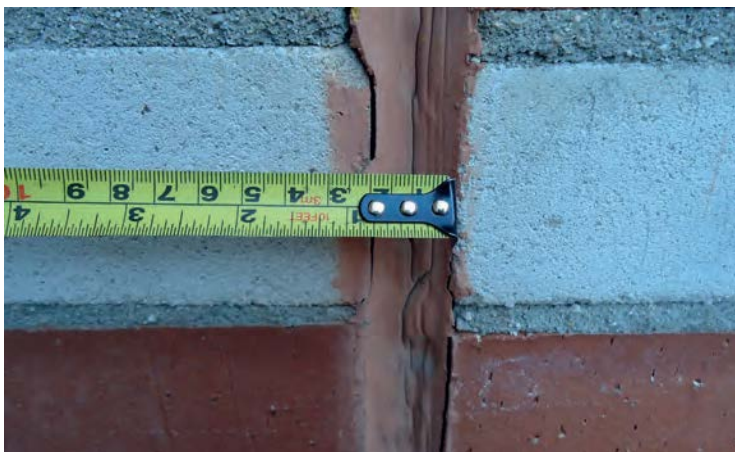
▲ Photograph 5-15

Since even the best silicones cannot guarantee stable deformation of over 20-25 %, a conventional 2-cm joint such as in Photograph 5-15 would accommodate movements of no more than 5 mm. Assuming that the distance between façade joints does not exceed the 12 m laid down in the building code and that total humidity-induced masonry expansion is no greater than 0.5 mm/m (some authors propose much higher values), in a matter of only a few years wall swelling would deplete the joint, which would be able to accommodate no additional deformation whatsoever.

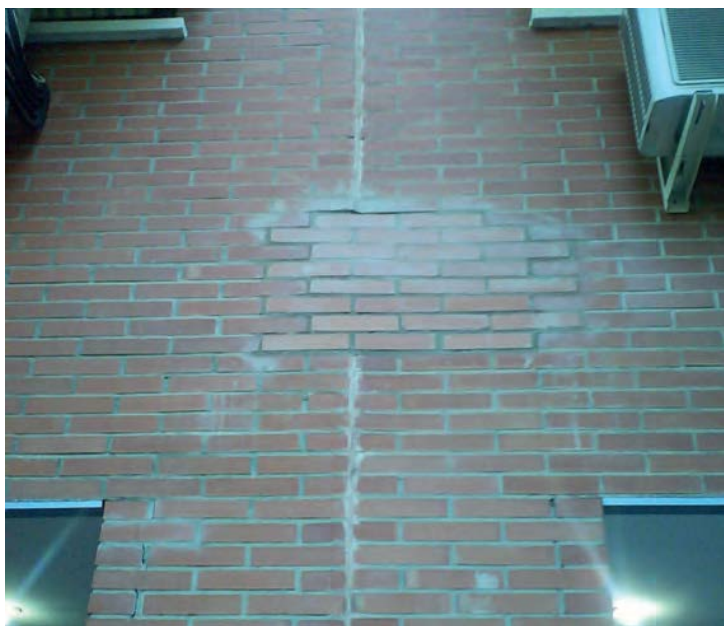
▲ Photograph 5-16

It would appear to be more cost-efficient to repair periodic joint damage than to make suitable allowance for these elements from the outset (note the “repair” of the joint depicted in Photograph 5-16 taken, like Photograph 5-15, in Madrid and thus unrelated to the earthquake).

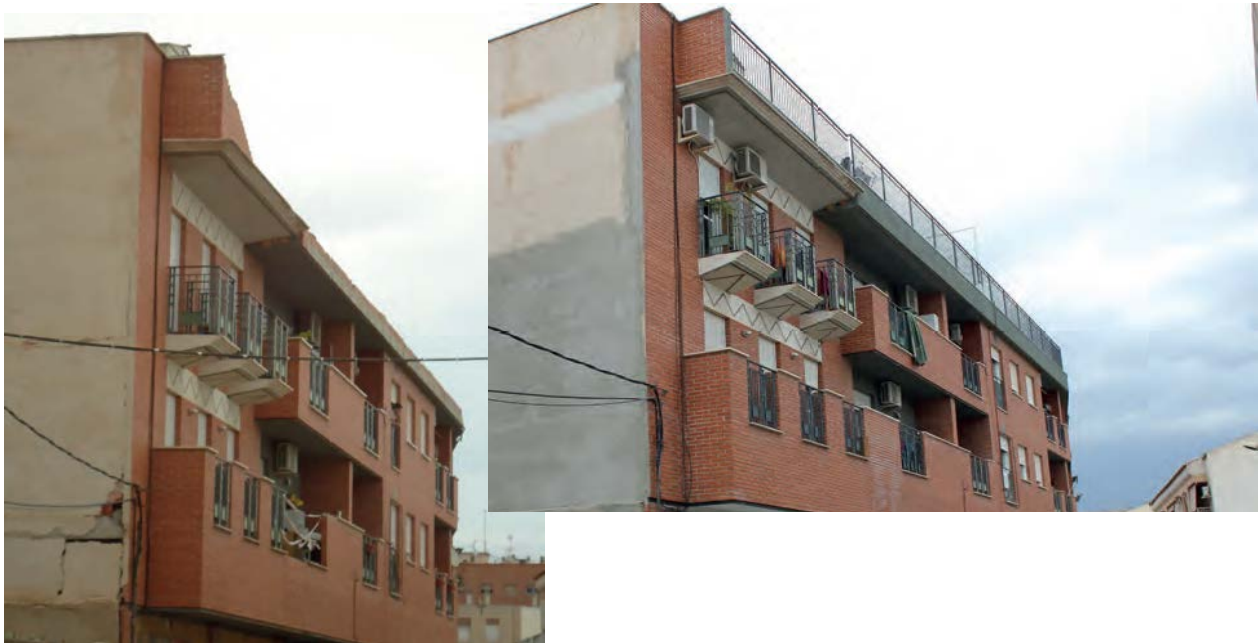
▲ Photograph 5-17

The complexities involved in applying such solutions may explain why these masonry parapets were not rebuilt after the quake, but replaced by steel railings. Photograph 5-17 shows a building damaged by the earthquake before and after repair.

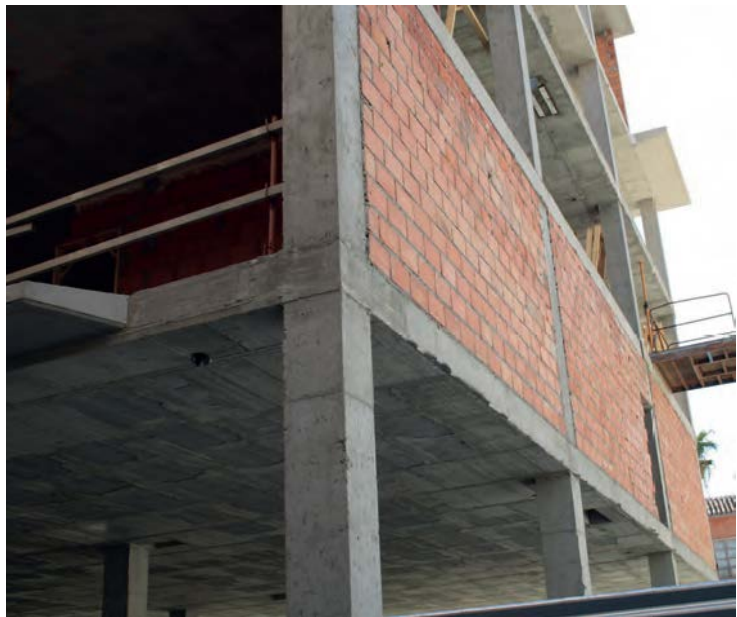
▲ Photograph 6-1

ter. The problem is more complex when the walls form part of a structural frame, as is often the case (Photograph 6-1). The complex behaviour exhibited by the infill-frame assembly differs from what is observed in the two elements separately and has yet to be fully quantified.

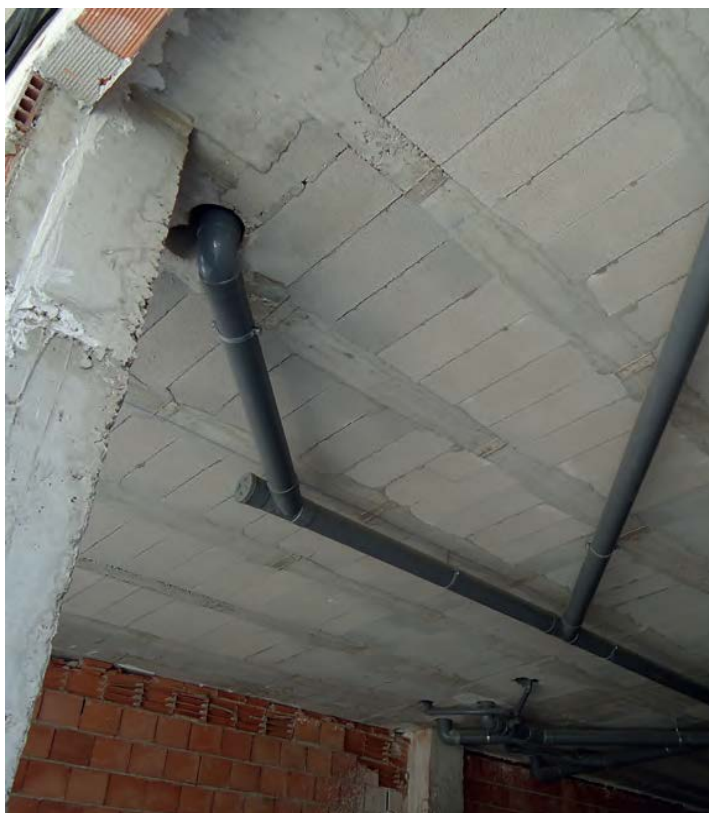
▲ Photograph 6-2

In fact, such walls are often the sole source of a building's stiffness and strength relative to horizontal actions. One of the structural designs frequently used in Spain consists of successive parallel rows of flat portal frames joined by one-way slabs (Photograph 6-2). Such a system cannot ensure sufficient stiffness or strength to counter horizontal loads in the direction of the slab, particularly in the case of steel frames, in which the joists simply rest on the beams with no connection whatsoever.

In such cases, building stability in that direction relies exclusively on the masonry infill. Nonetheless, contrary to expectations, in Lorca these buildings were not found to have an especially high damage rate, an observation that would infer that it was actually the non-structural elements that absorbed the seismic action.

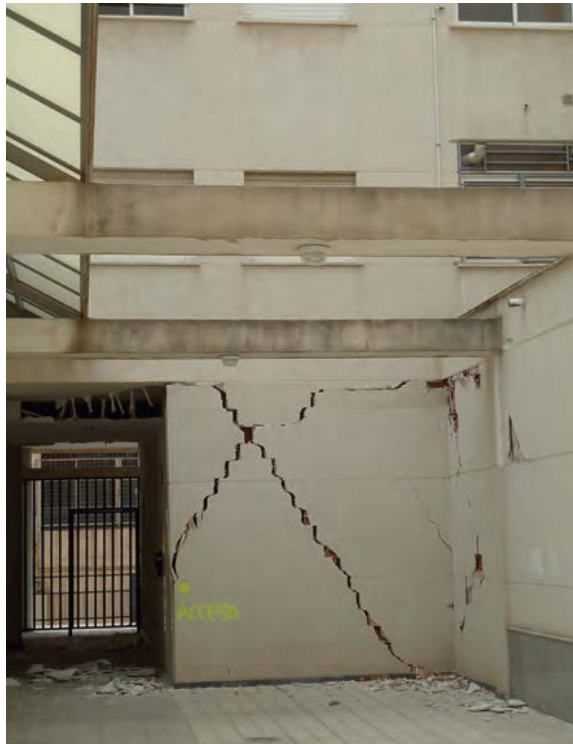
▲ Photograph 6-3

The value found is more than a full order of magnitude higher than the strength of any masonry wall. That would explain the failure in so many of the lower storey infills (Photograph 6-3) in Lorca and the aforementioned near irrelevance of the theoretical shear value.

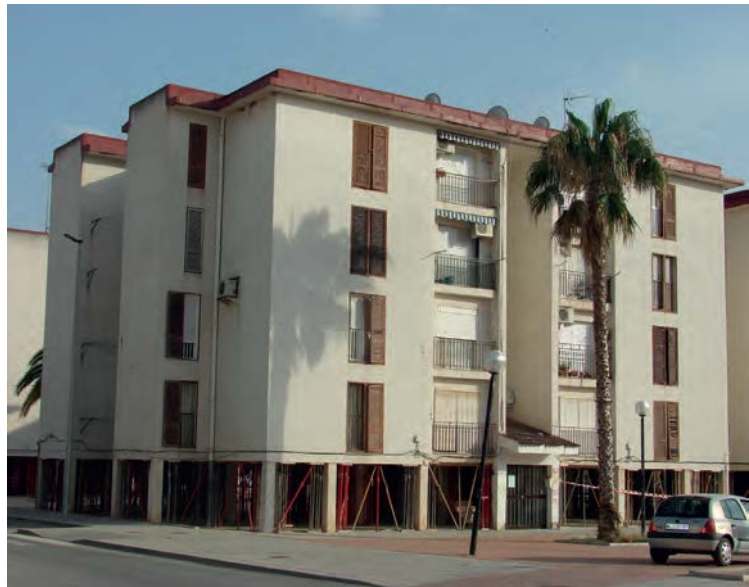
▲ Photograph 6-4

The aforementioned flexible storey mechanism often arises not as a result of ground storey masonry failure but of the lack of any infill on that storey. An example found in one of the buildings in San Fernando quarter at Lorca is depicted in Photograph 6-4.

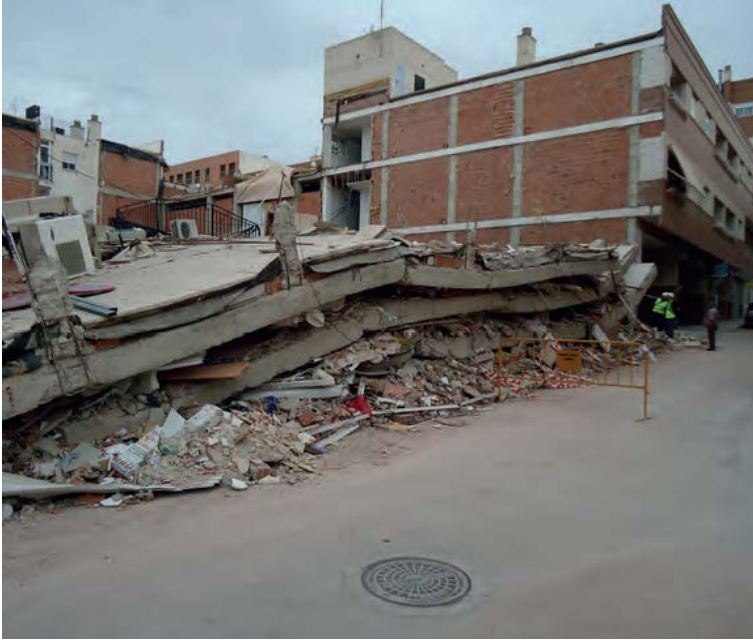
▲ Photograph 6-5

Buildings were much more frequently observed to have thick masonry infills as separation walls (Photograph 6-5). In buildings located on the corner of a city block, such walls would clearly generate in-plan asymmetries.

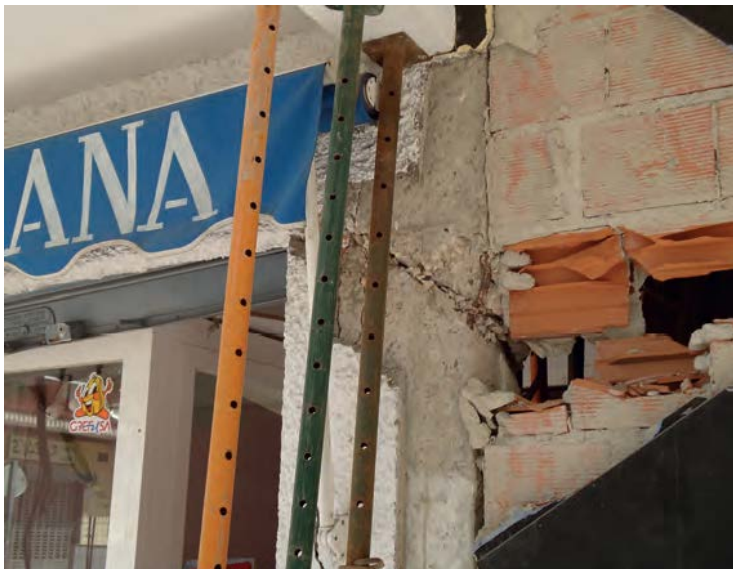
▲ Photograph 6-6

The most conventional mechanism would entail the formation of diagonal cracks, as shown in Figure 6-24 and Photograph 6-6. Column resistance in this situation can be assessed using the standard equations proposed in the legislation for linear elements (Spanish concrete code EHE, for instance [13]).

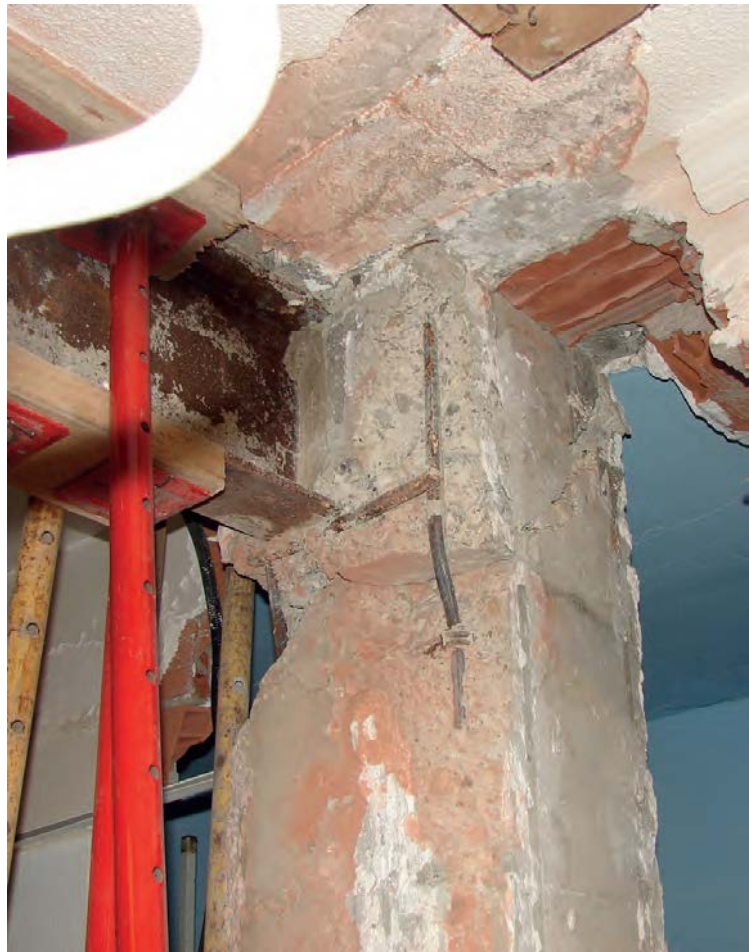
▲ Photograph 6-8

On occasion simple visual inspection of the damage at Lorca revealed negligent workmanship in the joint (note the smooth finish on the joint in Photograph 6-8 and the use of only two bars per side to reinforce the column).

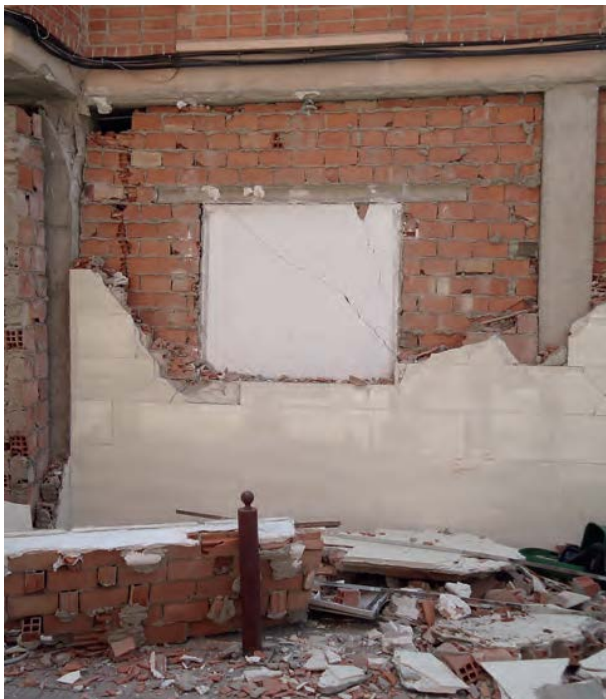
▲ Photograph 6-9

These types of failure are the result, of course, of uniform, controlled experimental set-ups. Less uniform and less regular real-life construction using variable materials would give rise to further mechanisms. At Lorca, new openings had been made in some infills, while in others former openings were covered up (Photograph 6-9). Walls were built with all manner of brick, highly disparate bonds and a very wide variety of fills, especially in the upper rows. As a result, failure followed a completely different and in all likelihood less hazardous pattern than observed in frame-in-fill tests (although the latter assertion would need to be verified).

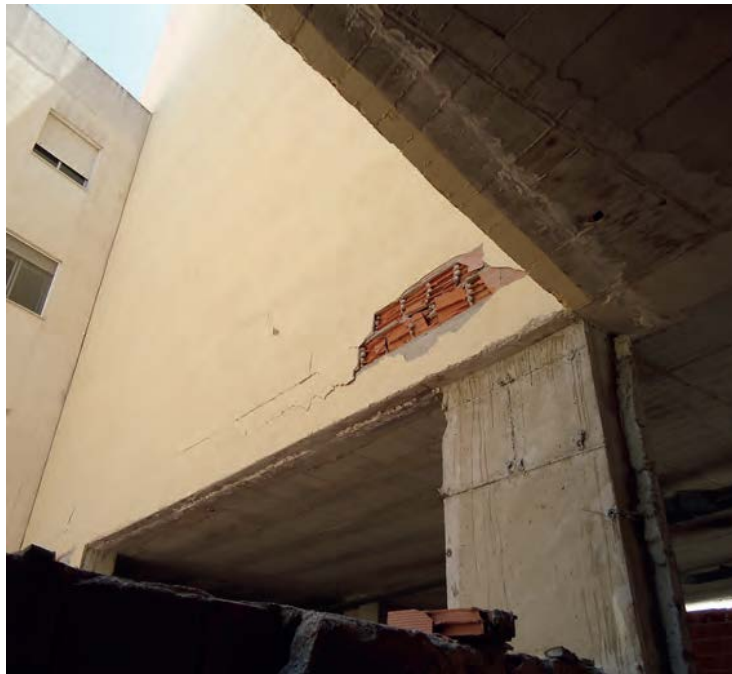
▲ Photograph 6-11

At Lorca, damage was consistently observed at the frame-infill interface, as shown in Photograph 6-10, although this is not, strictly speaking, a failure mode, for it involves a loss of stiffness but not of strength. Failure types similar to the ones described earlier were also identified. Photograph 6-11 depicts a masonry wall crushed at the corners and Photograph 6-12 mortar joint failure.

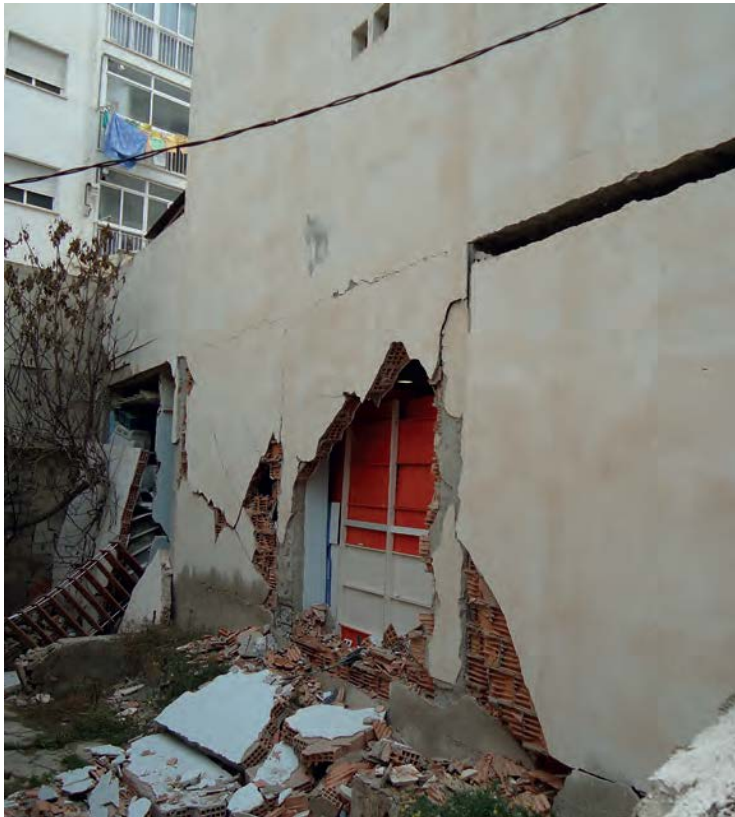
▲ Photograph 6-13

A more common type of failure, shown in Photograph 6-13, may be a combination of several of the basic types described by Crisafulli.

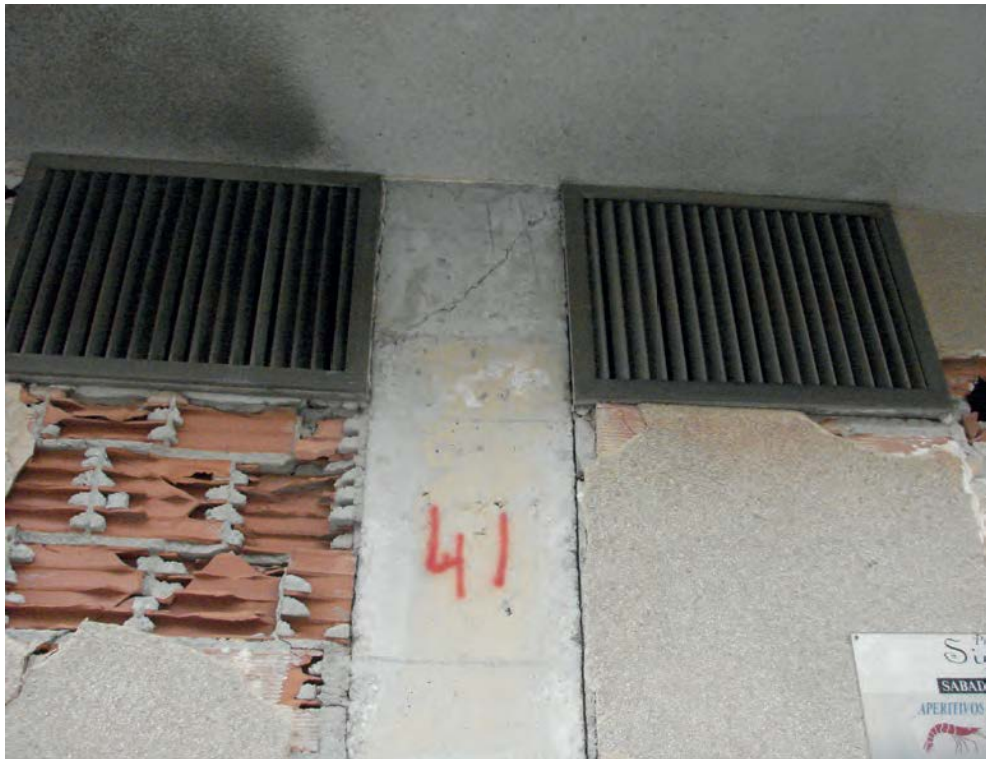
▲ Photograph 6-14

The above discussion assumes the most elementary situation, in which a blind masonry wall covers the entire span. The contrary, illustrated in Figure 6-31 and Photograph 6-14 and known as the “*captive column*” in the literature, induces short column failure, as discussed at some length below.

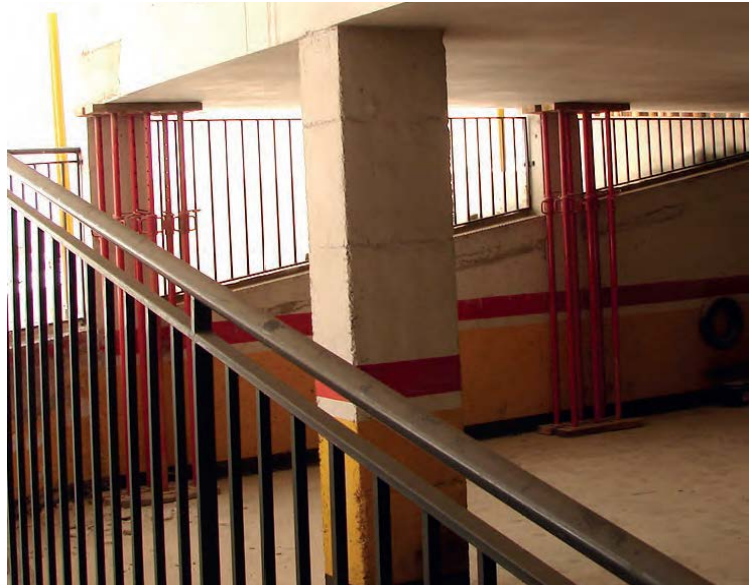
▲ Photograph 7-2

most hazardous, example of this situation. Similar problems arise when a building is sited on a slope and the first storey elevation is maintained by varying the length of the columns (Figure 7-2 A). The problem is naturally the same if the end column springs from the same elevation as the others but is built adjacent to the basement wall (Figure 7-2 B). The slabs forming the access ramps in car parks are subject to an identical hazard. The damaged columns in Photograph 7-2 (the photograph does not depict the damage itself, but it does show the bracing) were sited under such a ramp.

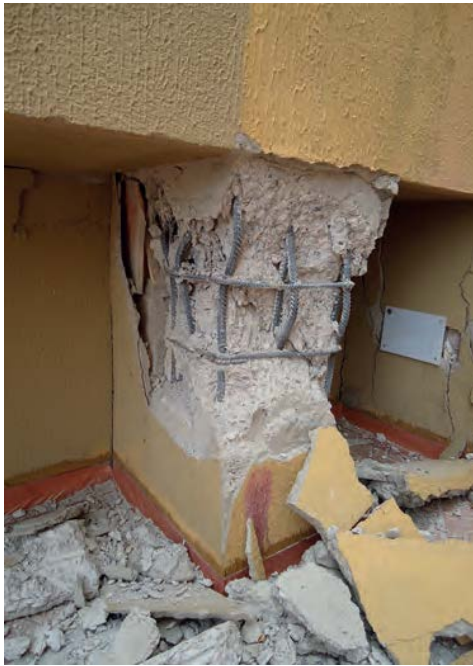
▲ Photograph 7-3

Note that this and the preceding criterion are complementary. Here the issue is not a short column in a line of normal columns, but one that is short enough to exhibit shear failure. In fact, all the short columns (and the vast majority of columns, short or otherwise) observed to fail in Lorca failed in shear (Photograph 7-3).

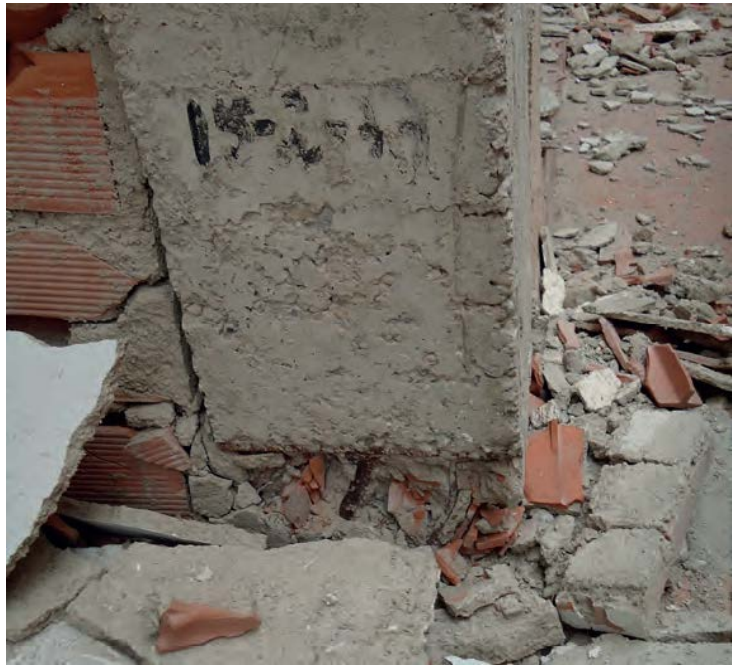
▲ Photograph 7-4

Shear failure may not necessarily follow the standard pattern. If masonry infills are present, the construction joint may slide first (Photograph 7-4), providing further proof of the stiffness and strength of such elements.

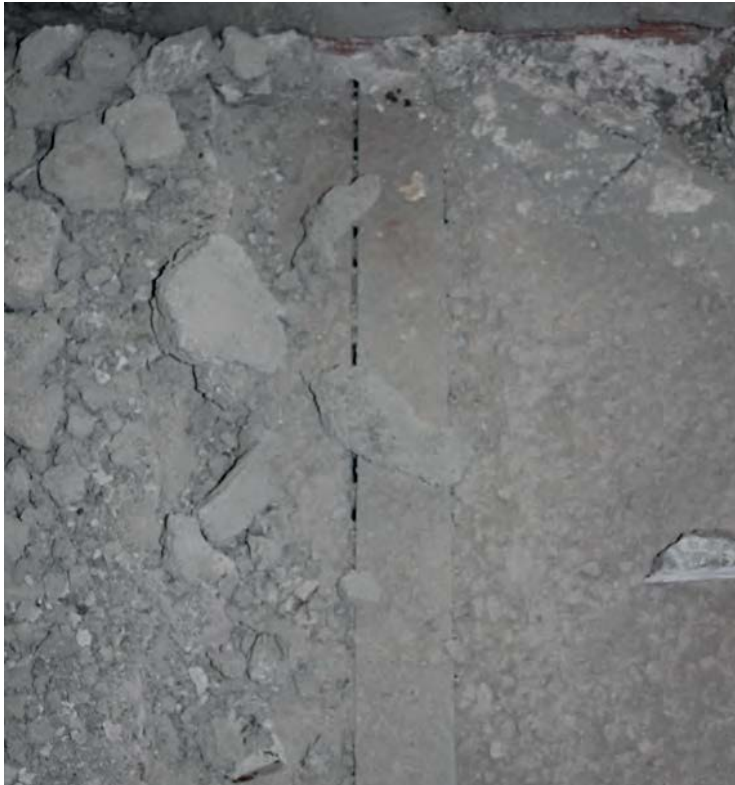
▲ Photograph 7-7

While many of the buildings inspected at Lorca had no slab topping, the damage observed was not as severe as might have been expected, at least in collective housing. No slab deformation or damage attributable solely and directly to non-monolithic construction was in fact observed. The possible symptoms were confined to the widening of joints between floor tiles, whose origin in many cases may very likely have been prior and unrelated to the earthquake. In fact, in some cases inspection holes in the floors revealed that the joists and fill seemed to have pulled apart (Photograph 7-7) for reasons not attributable to the quake.

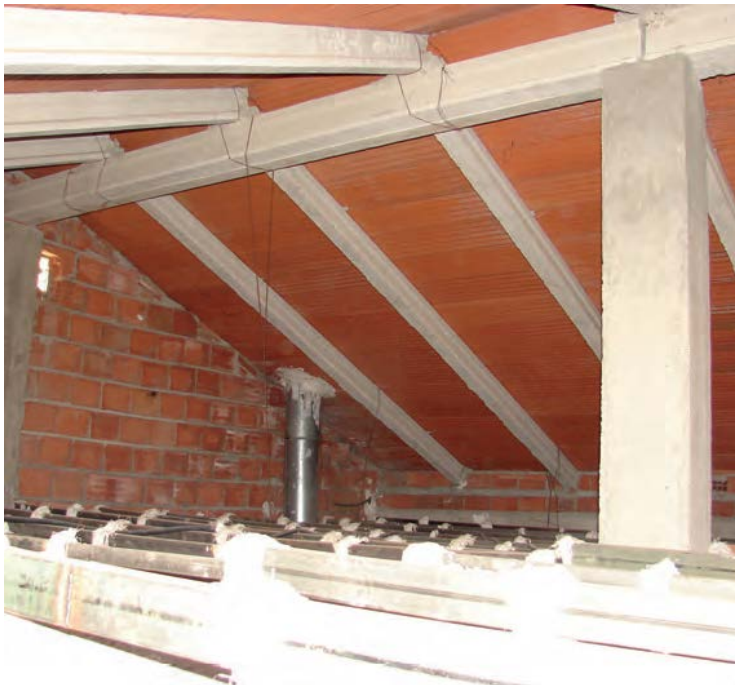
▲ Photograph 7-8

Flooring was found to have been deformed in some single family dwellings, with gaps between joists and structure or even out-of-phase inter-joist displacement. In most cases, the floors in question were made of timber in which the joists, mere logs, lacked any strong connector at the bearing. In concrete slabs, the same problem was only observed where the structural configuration was particularly deficient and formally identical to the timber flooring, probably due to a lack of professional advice (Photograph 7-8).

Other cases were found in which the structure was only effective vertically, due the absence of any real connection between the bars (beams that simply rested on columns, as in Photograph 7-8 above).

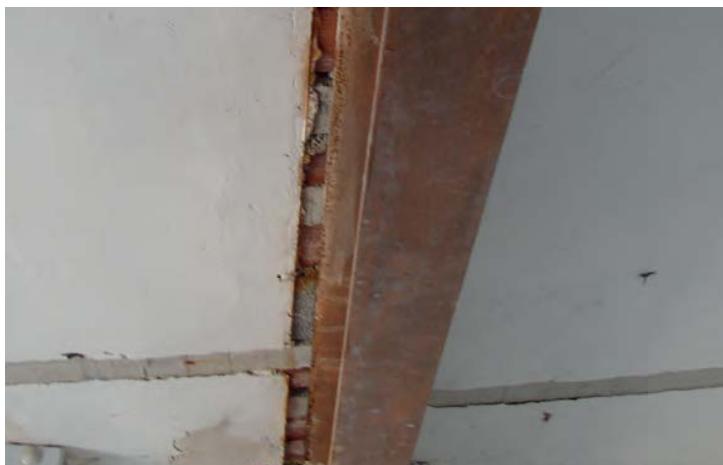
▲ Photograph 7-9

The whole slab was observed to have slid across the beams in some cases, but only where the beams were made of steel and unconnected to the slab (Photograph 7-9).

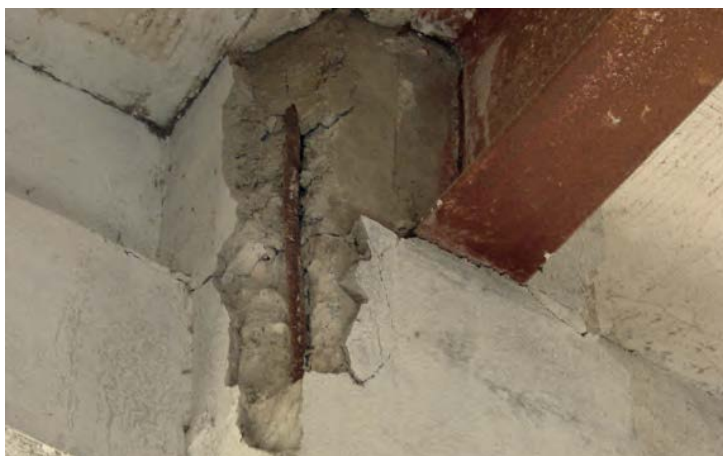
▲ Photograph 7-11

The same problem appeared in a structural scheme found fairly frequently in the city, characterised by the use of steel beams and concrete columns (Photograph 7-11). In such cases, the beam-column joint cannot guarantee the minimum stiffness required and the assembly fails to constitute a true portal frame. In response to lateral loads, the structure behaves like a series of cantilevered columns. The actual configuration was even less favourable, for column strength was nullified around the joint, where the steel shape hindered proper concrete casting, interrupting the continuity of stress flow across the member. A more serious consequence, however, was that it prevented concrete confinement and the application of tie bars to hold the reinforcing steel in place.

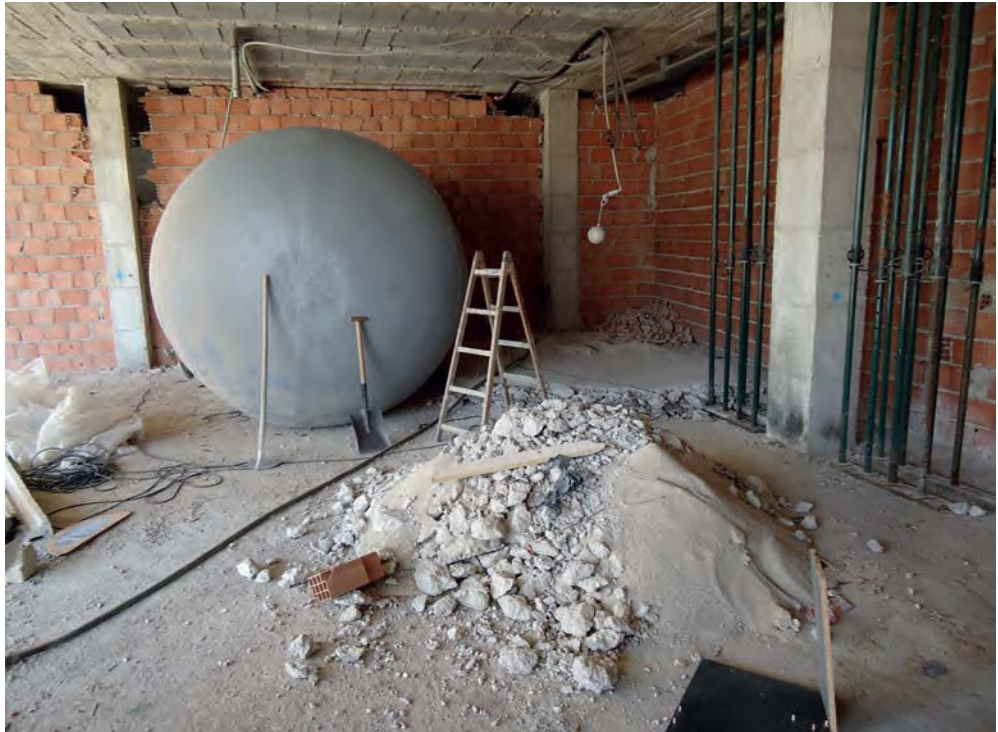
▲ Photograph 7-12

One of the most surprising observations from the very outset was the large number of tanks, some very sizeable (Photograph 7-12), housed in conventional buildings. Their existence was the

outcome of legal provisions that call for a minimum guaranteed volume of water in certain types of public premises. While these deposits were highly unlikely to have ever been filled to capacity, probably because that would have induced the collapse of the underlying floor slab, they constituted an inadmissible hazard in a seismic zone.

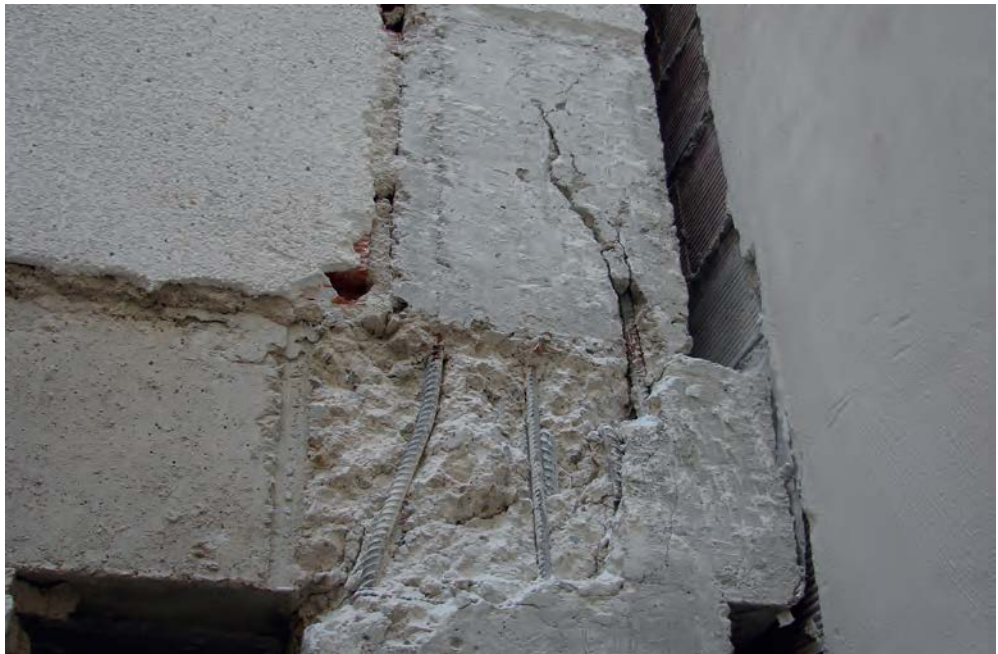
▲ Photograph 7-15

Not a single case was found to comply with that hierarchy. Beams were not observed to form hinges (which should be the first effect of seismic forces), while shear failure, which should not have occurred under any circumstances, was detected in dozens of columns. Nor, of course, should joints have failed like the one in Photograph 7-15. Note, moreover, the lack of tie bars and the absence of any joint with the adjacent building.

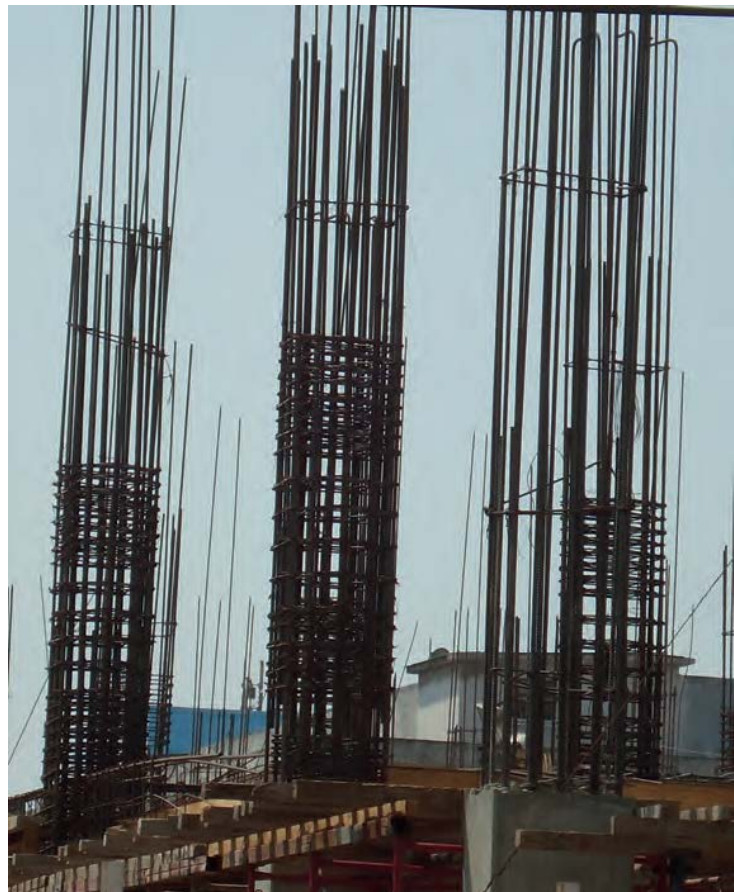
▲ Photograph 7-16

A comparison between that and the following picture, Photograph 7-16, taken in a low seismicity area in Mexico, is revealing. Note the ratio of tie bars at the connections.

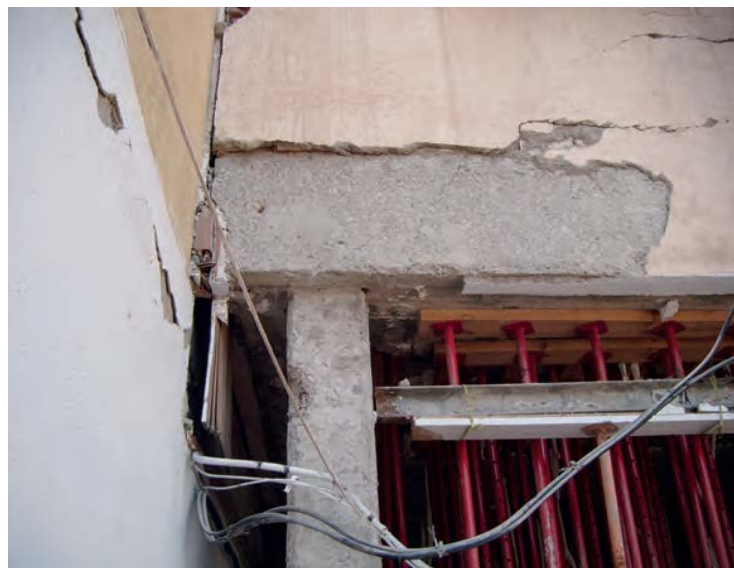
▲ Photograph 7-17

In short, many of the city's structures were not compliant with the classical "*weak beam / strong column*" principle, and their geometry (Photograph 7-17) suggested the exact opposite.

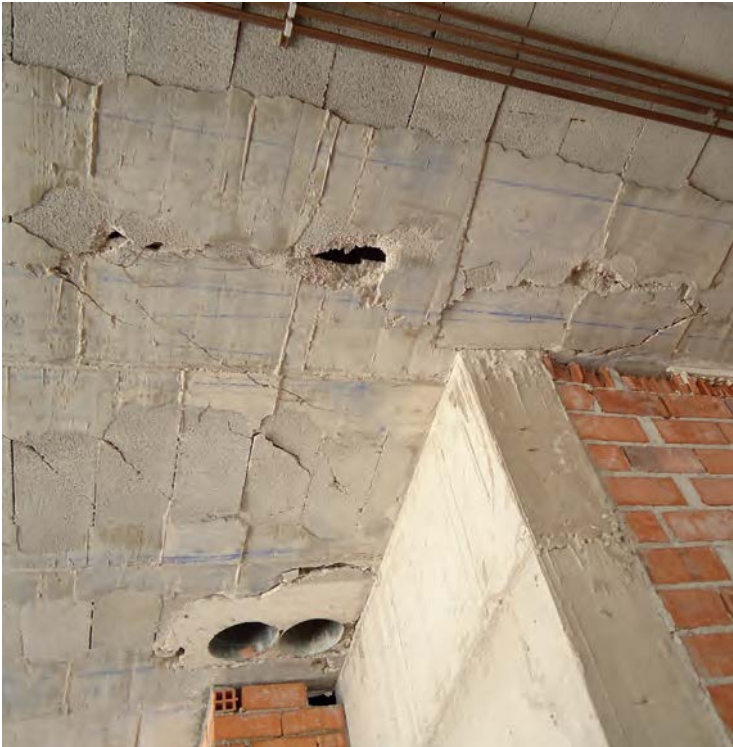
▲ Photograph 7-18

Since such elementary precautions were not always adopted at Lorca, in some cases the shear wall literally cut through the floor slab. Note the 45° angle cracks in the slab alongside the shear wall in Photograph 7-18, and the crushed waffles along its entire length. A continuous beam would obviously have been needed to extend the bracing plane.

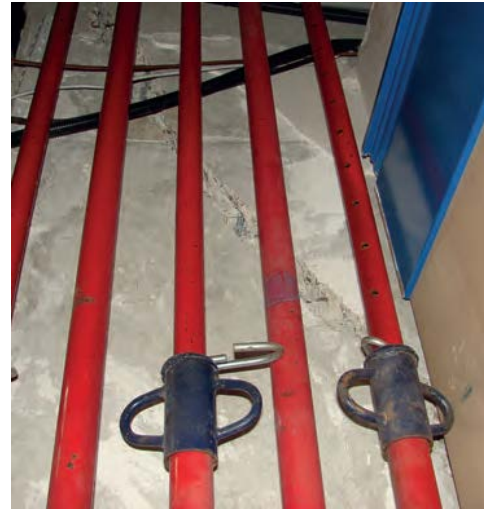
▲ Photograph 7-20

Another factor that governs shear wall behaviour is the reinforcement used. Meeting the basic requirement of earthquake-resistant design, i.e., preventing brittle failure, leads to extraordinarily costly reinforcement, with steel ratios, particularly for horizontal forces, much larger than observed at Lorca (Photograph 7-19). The shear failure of many such walls could be attributed to these reinforcement shortfalls (Photograph 7-20).

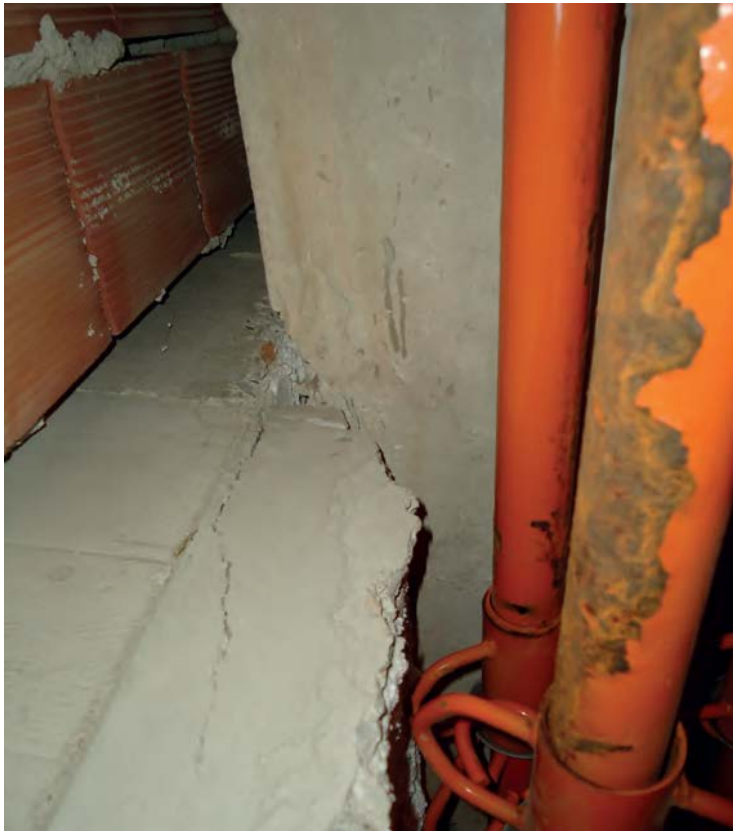
▲ Photograph 7-21

Where floor slab elevations did not concur, in some cases the more recent building literally penetrated the perimeter of the older one, up to the outer leaf. In such situations the slabs on the newer building were found to embrace the columns on the existing one (see Photograph 7-21, in which the slab in the building on the left can be seen to surround the columns in the building from which the photo was taken on the right).

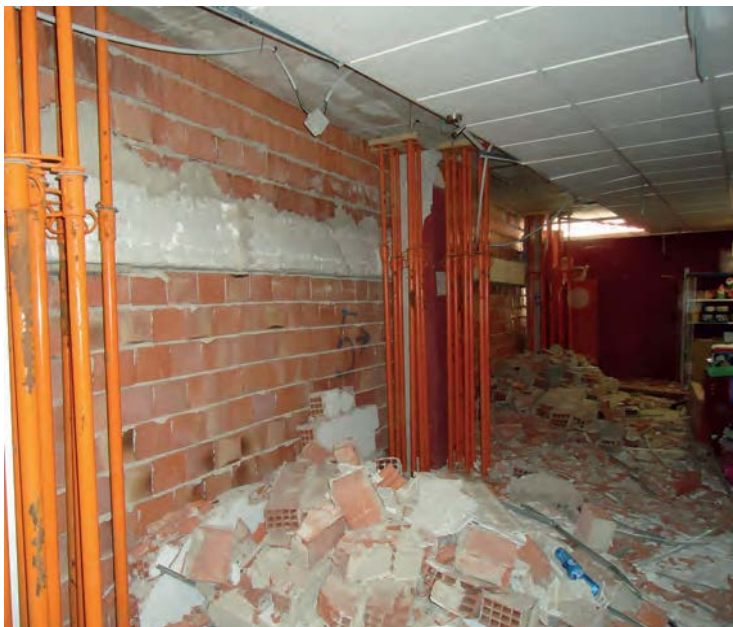
▲ Photograph 7-22

That practice naturally induced very severe damage in the structures and the very robust outer masonry walls, whose collapse constituted a serious hazard (Photograph 7-22).

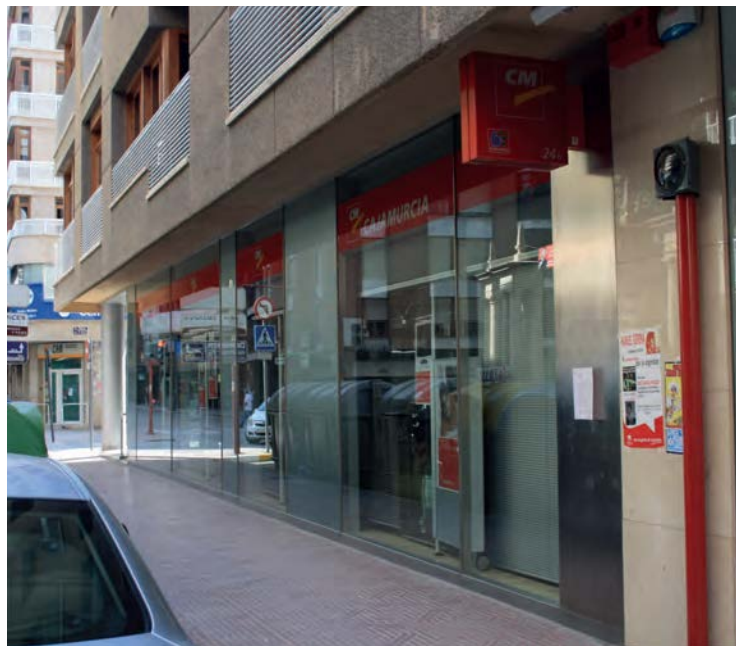
▲ Photograph 7-23

would indeed have to be designated as “*weak*” rather than “*soft*” because they constituted a sure hazard in the event of an earthquake. They were normally the result of architectural considerations and urban ordinances requiring store-fronts to have greater clear heights. The outcome was ground storeys with insufficiently reinforced columns that were taller than the ones in the rest of the building, and often with provisional, fairly weak, hastily built brick or even glazed enclosures unconnected to the structure (Photograph 7-23).

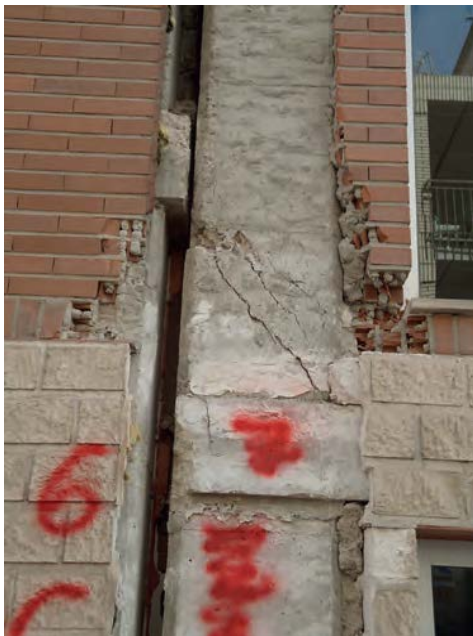
▲ Photograph 7-24

The clearest consequence of these situations in Lorca was the frequency with which pounding was observed on the first storey (Photograph 7-24).

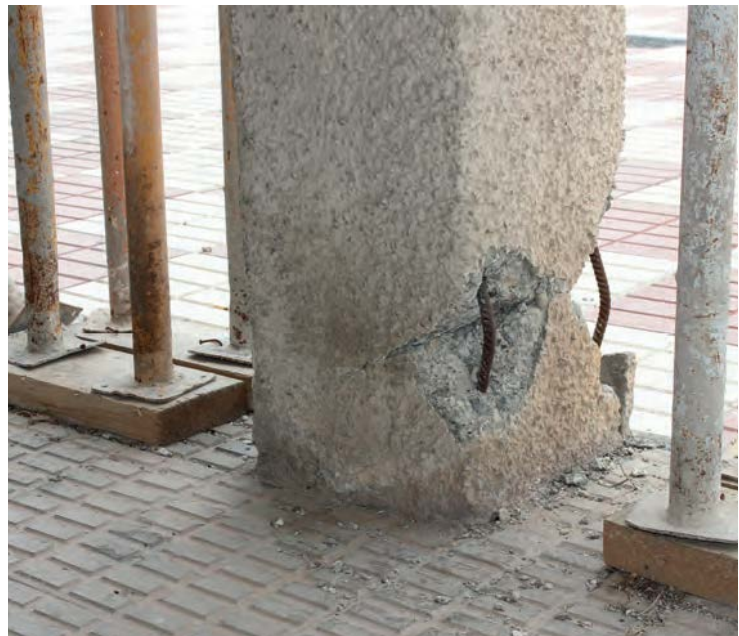
▲ Photograph 7-25

Outside of pounding, no major damage was found on the lower storeys of buildings that could be solely and directly attributed to weak storey behaviour. Some kinds of damage, such as reinforcement buckling at the top or bottom of some columns in San Fernando quarter buildings (Photograph 7-25), was clearly caused by a need for greater ductility than extant in the section. Nonetheless, failure could actually be more clearly attributed to inadequate reinforcement and careless workmanship (as shown in the scant concrete cover. Note the rust on the reinforcement bar, denoting cover loss prior to the quake.)

It is hard to imagine that a circular bar 12 mm in diameter and more than 20 cm long can be compressed to much beyond its yield strength without buckling, but that was exactly what was observed in some lengths of columns at Lorca, where the stirrups were spaced at more than 20 cm and the concrete cover had disappeared years earlier.

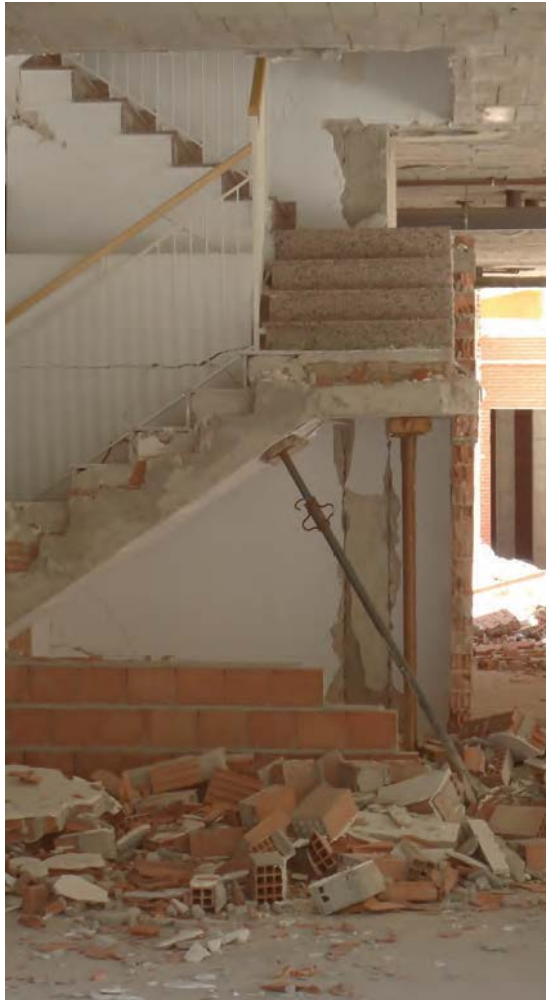
▲ Photograph 7-26

Many standard configurations obviously failed to comply with this idea, for they entrusted their stability to the support afforded by the stairwell masonry which, as discussed below, is one of the first elements to fail in earthquakes, leaving the stair slab in precarious condition (Photograph 7-26).
