The Lorca Earthquake

Effects on buildings

INTEMAC

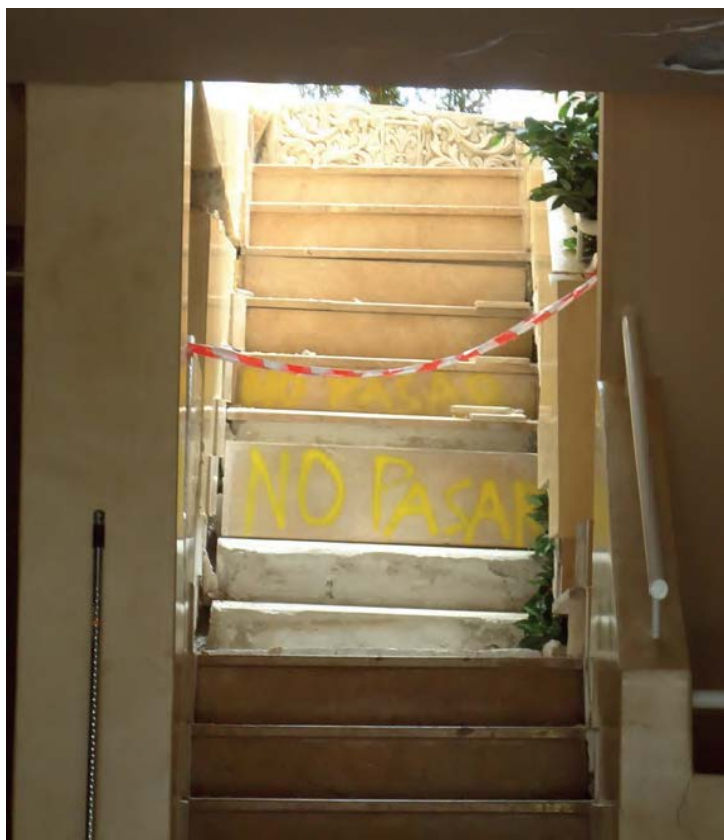
▲ Photograph 7-27

Staircases also exhibit the dual behaviour described in connection with masonry walls. On the one hand, as passive elements, their constituent slabs are stressed by building displacement, which induces forces for which they are not normally designed (Figure 7-14, often causing their collapse (Photograph 7-27). The consequences of staircase failure are severe and so obvious that no need is felt to insist on the importance of prevention.

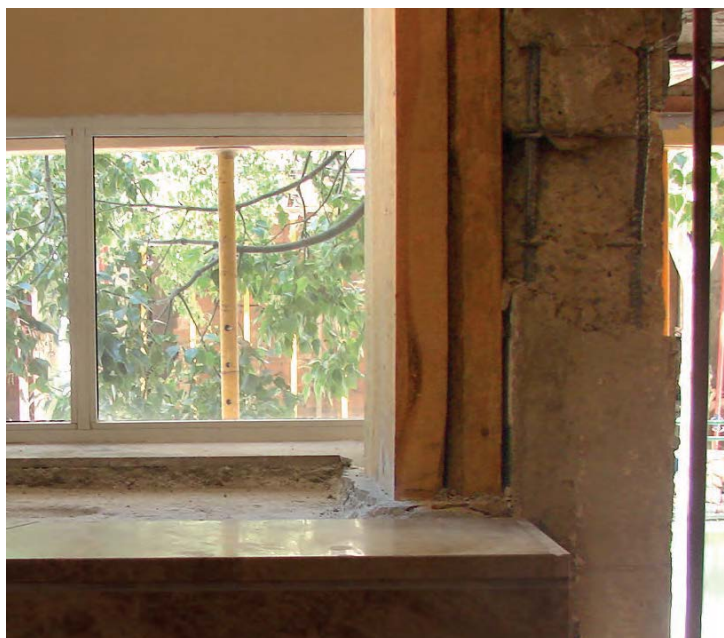
▲ Photograph 7-28

Lastly, the greatest impact on structural strength occurs when staircase slabs are attached to or simply abut against a column, for that induces a short column mechanism with the foreseeable consequences (Photograph 7-28).

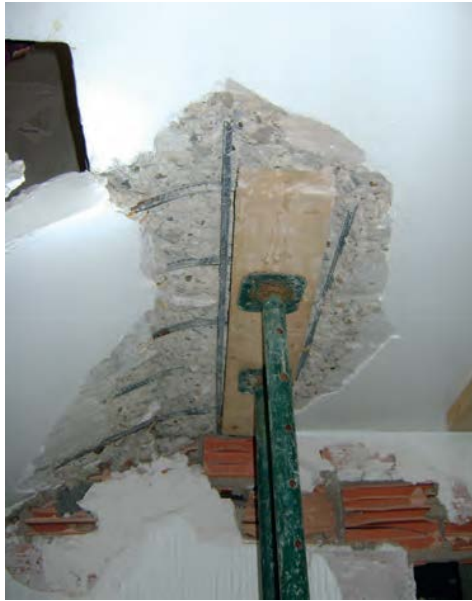
▲ Photograph 7-29

More surprising, given both the elementary nature of the problem and the frequency with which it was observed, was failure due to the thrust of the tensile reinforcement in the slab (Figure 7-15). The textbook principle calling for securing the reinforcement to the compression head often went unheeded, causing severe damage along the inter-flight or flight-landing angle (Photograph 7-29).

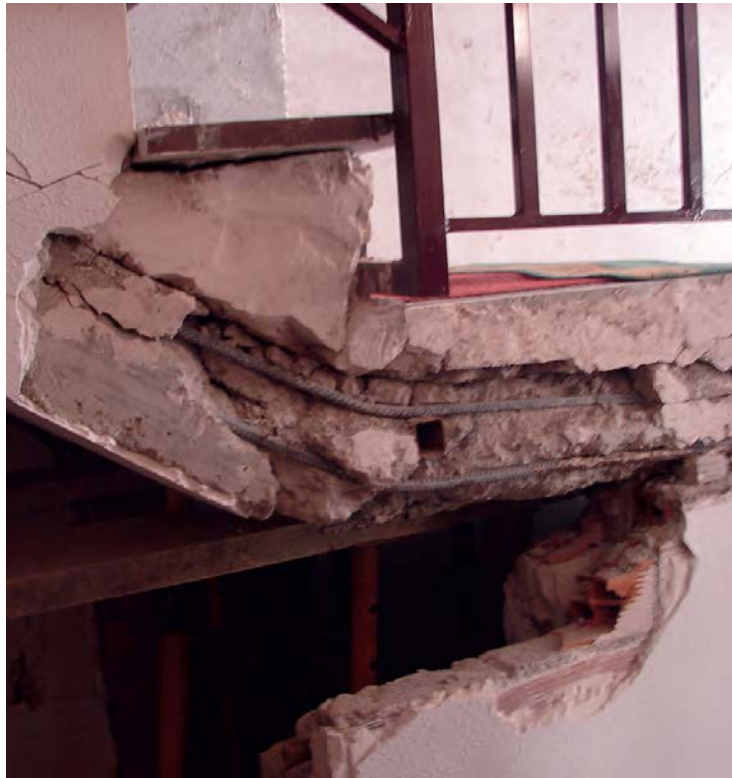
▲ Photograph 7-30

Photograph 7-30 shows the reinforcement arrangement in many staircase slabs, which is unable to ensure even minimum safety.

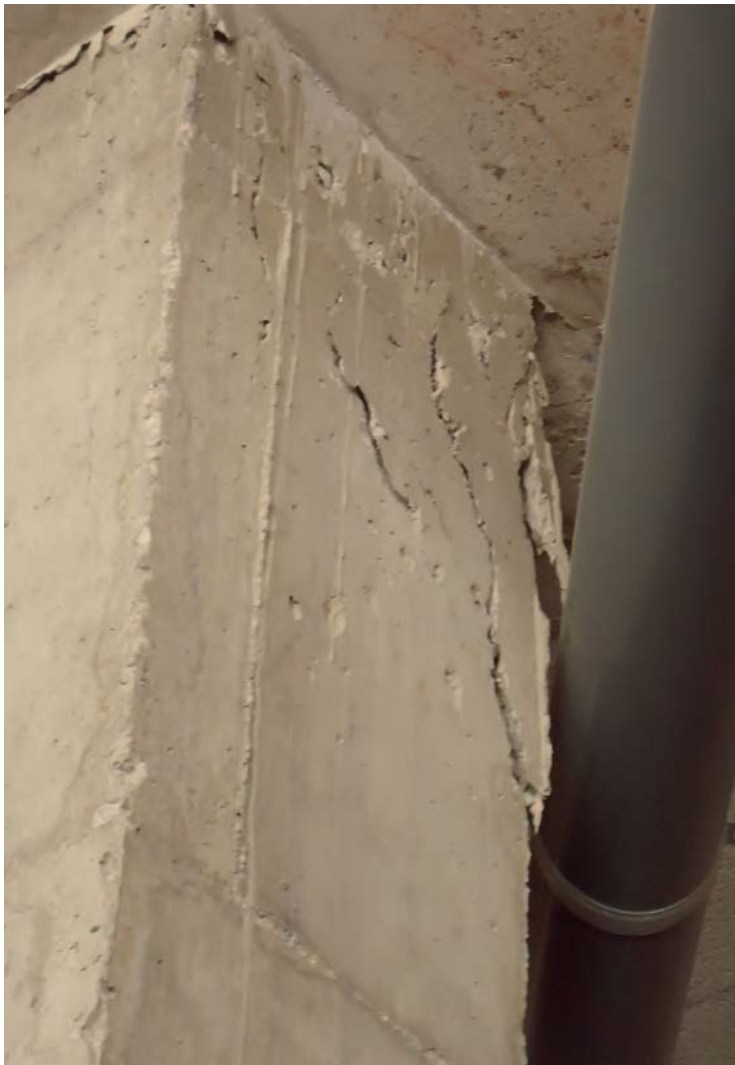
▲ Photograph 7-31

Transverse reinforcement also conditioned concrete confinement and consequently its ultimate strain under compression, an essential issue in compressed sections. Nonetheless, this type of failure could be clearly identified on only a few occasions in Lorca (Photograph 7-31).

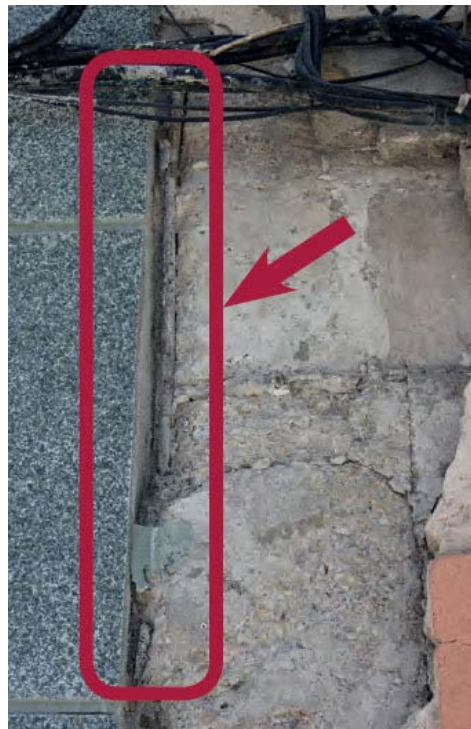
▲ Photograph 7-32

Much wider spacing was systematically measured at Lorca, reaching an extreme at nodes, where tie bars were apparently not deemed necessary (Photograph 7-32).

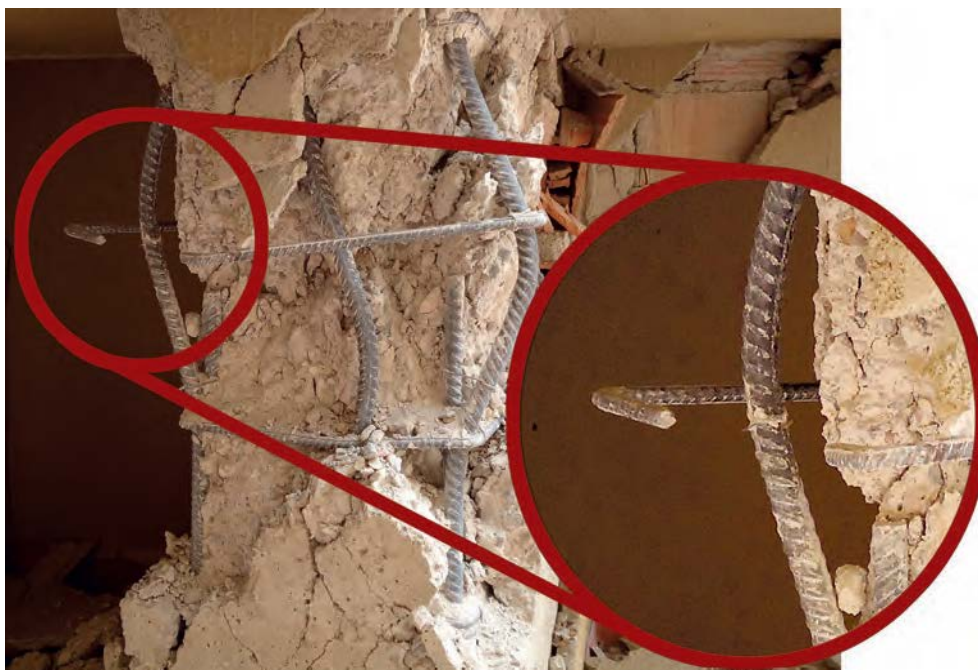
▲ Photograph 7-33

Although this is an obviously more complex solution, it is the sole way to ensure that the tie bars continue to serve their purpose when they are most needed, i.e., in the absence of the concrete cover (Photograph 7-33, which also shows that the bar was spliced on the side under greatest stress).

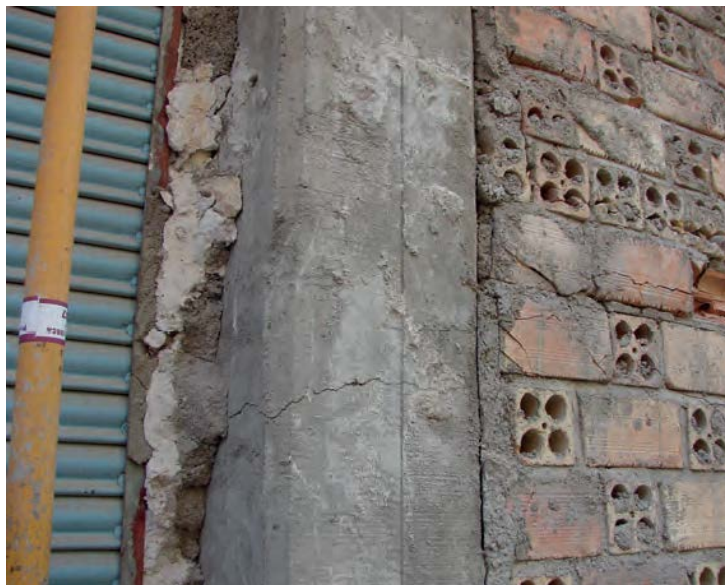
▲ Photograph 8-1

Although in Figure 8-1 these cracks are drawn at the top and bottom of the column in keeping with structural logic, they were also observed at mid-height (Photograph 8-1), where the moment is theoretically nil. In the column shown in the photograph, they were induced by the failure of the adjacent masonry infills (in other cases the origin may lie in staircase slabs or basement ramps).

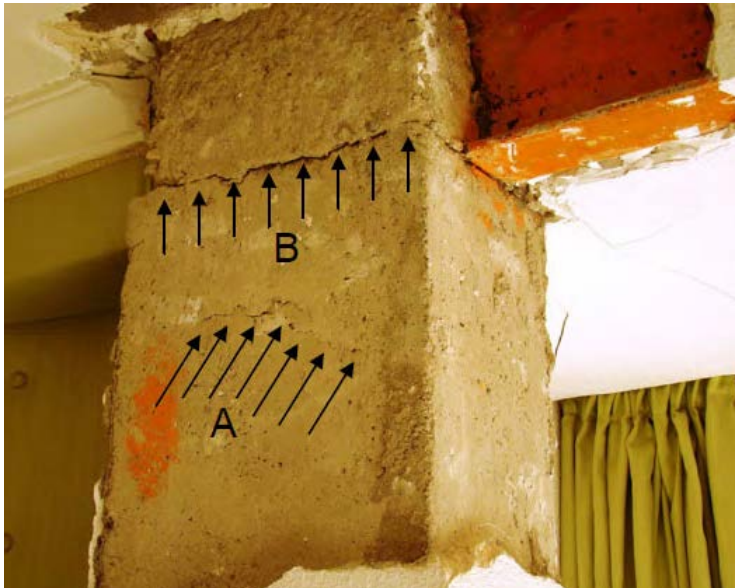
▲ Photograph 8-4

In fact, when joint surveys were conducted with the authors of those reports, the origin of many of the cracks was shown to have been prior to the quake and completely unrelated not only to it but even to any external action. Some cracks, such as the one labelled A in Photograph 8-4, which concurred with the tie bars in the columns, had appeared due to plastic settlement during construction. Others proved to be mere construction joints, such as B in the photo. Yet other cracks arose early in or throughout the life of the building (shrinkage cracks in beams and reinforcement corrosion cracks, respectively).

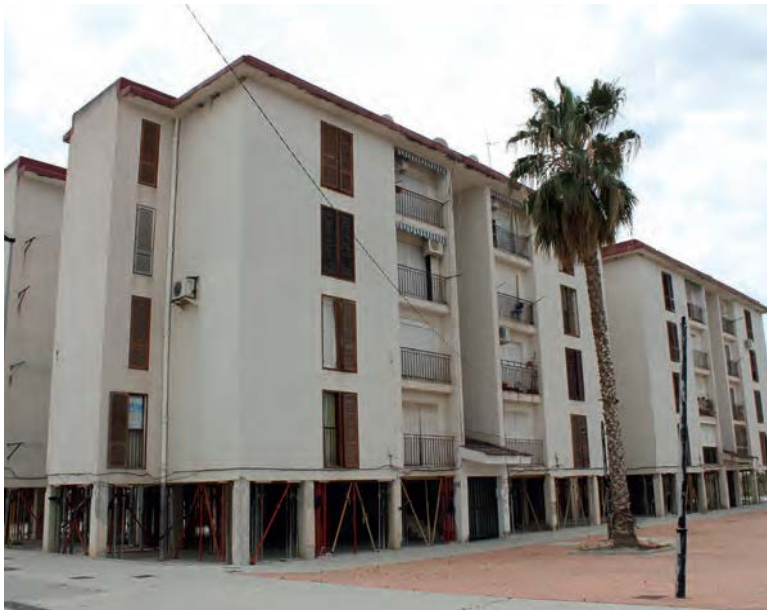
▲ Photograph 8-6

Indeed, these members acted as unplanned damage concentrators (see Benavent-Climent for an especially enlightening description of the term), limiting the spread of the harm to the rest of the building to a certain extent. The same may be said of the buildings in San Fernando quarter (Photograph 8-6), repeatedly referred to throughout this text. Both their overall design and their detailing were particularly unsuited to a seismic zone and they have been cited as examples of the most severe problems that buildings may pose (weak storey, unsatisfactory reinforcement, steel corrosion and loss of cover, to name a few).

Paradoxically, however, repair of these buildings was particularly simple because all the damage, irrespective of severity, was concentrated in a few specific members (columns) that were, moreover, readily accessible (from the ground with no need for any scaffolding whatsoever), mostly unengaged (avoiding the need to demolish masonry walls) and cleanly (without rubble) and conventionally reparable.

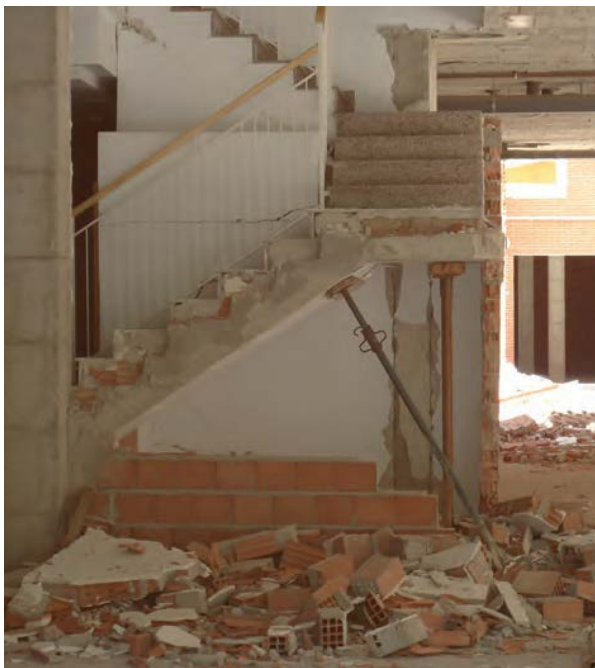
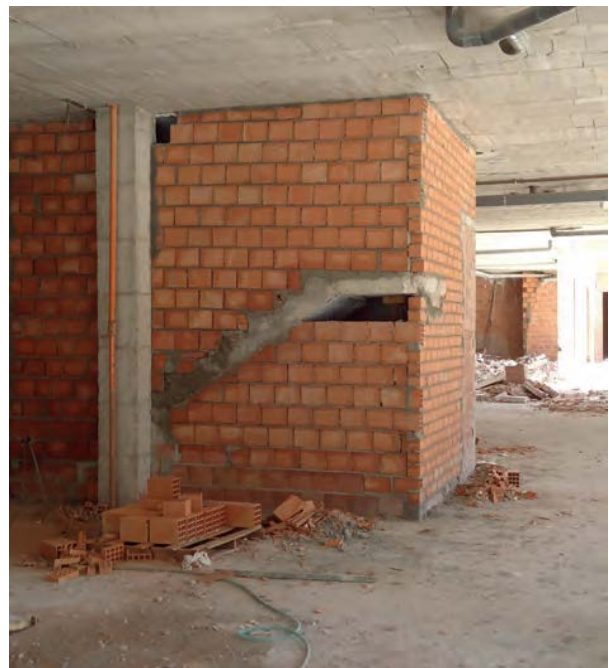
▲ Photograph 8-7

Photograph 8-7 depicts a staircase before (the same photograph is reproduced in item 7.6, “Staircases”) and after it was repaired.

The repair solution deployed was the simplest possible: to rebuild the original structure. The problem is that the original structure was clearly flawed, as the earthquake itself showed.

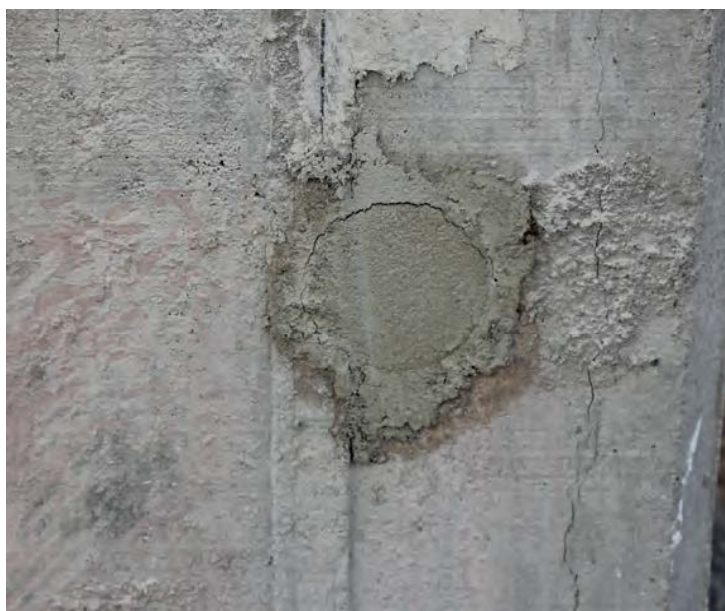
▲ Photograph 8-9

The object of Photograph 8-9 is sure to be familiar to anyone who has worked at Lorca for any amount of time: the perimetric crack that clearly denotes detachment of the repair mortar.

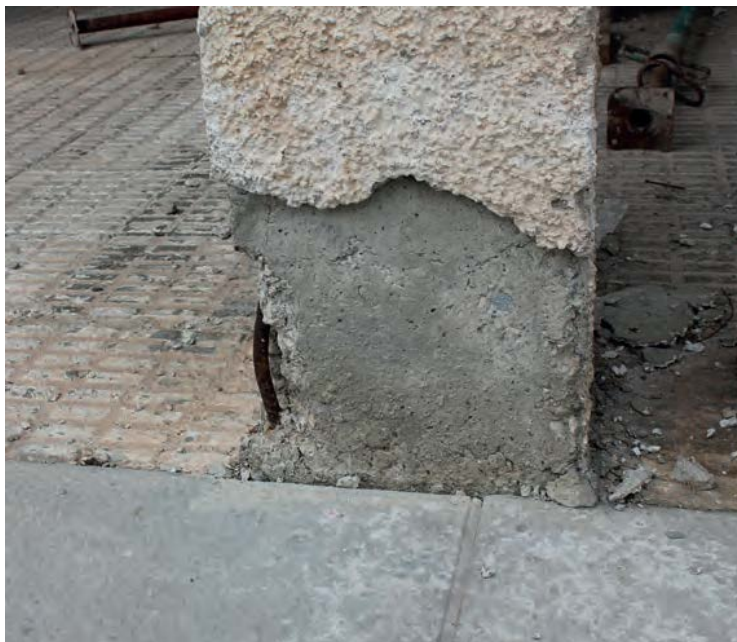
▲ Photograph 8-11

This item describes situations such as depicted in Photograph 8-11.

In such cases the main concern is to eliminate the buckled length of bar to prevent the thrust that would be generated when the bar is re-loaded (Figure 8-2).

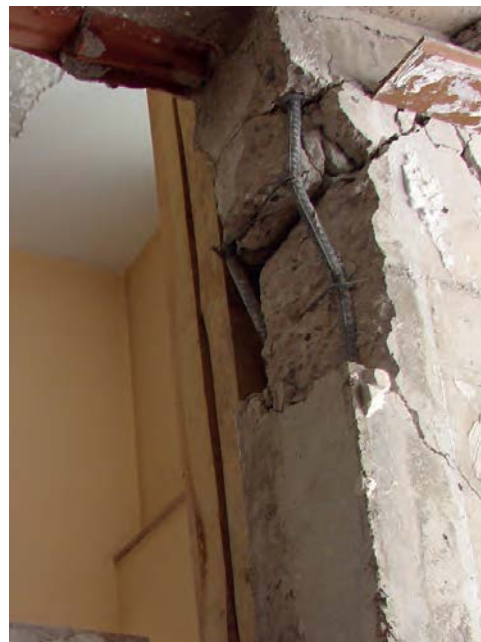
▲ Photograph 8-12

The reference here is to damage such as depicted in Photograph 8-12.

The most effective repair in this case is deemed to consist of rebuilding the damaged member as nearly as possible to design, respecting not only geometry but also material characteristics. The sole variation on the original would be to increase the number of tie bars and naturally anchor them with 135° hooks.

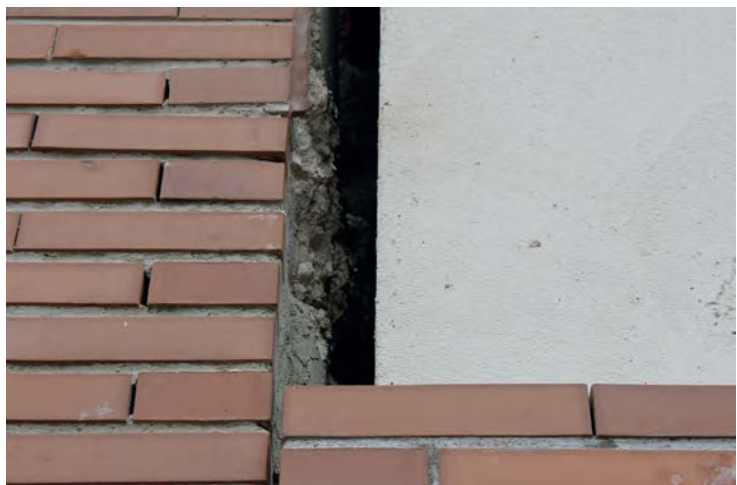
▲ Photograph 8-13

Such is the case of the building portrayed in Photograph 7-24 and included in Photograph 8-13 above. The latter also shows the result of the repair some months later. Note the (well-advised) effort made to demolish the end of the floor slab in the building on the left, which would have collided with the column on the one on the right, with visible results.

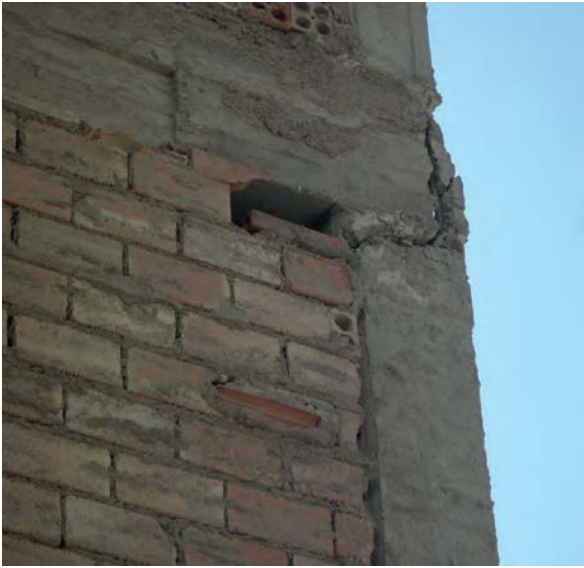
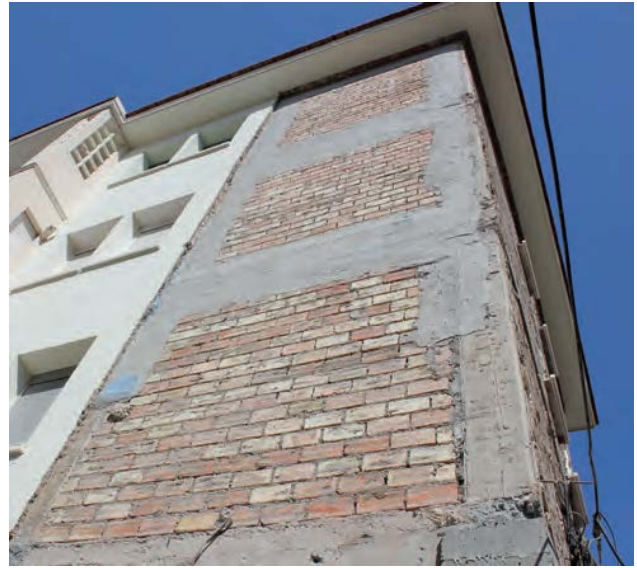
▲ Photograph 8-14

Photograph 8-14, likewise shown in earlier chapters, illustrates the damage caused by masonry walls that were often stronger than the columns framing them. Strengthening those walls, as depicted in the photograph, will very likely weaken the structure. In some of the buildings in Lorca whose columns clearly fit the “*captive column*” failure pattern, after repairing the column, the enclosures were rebuilt with the same geometry but even stronger masonry.

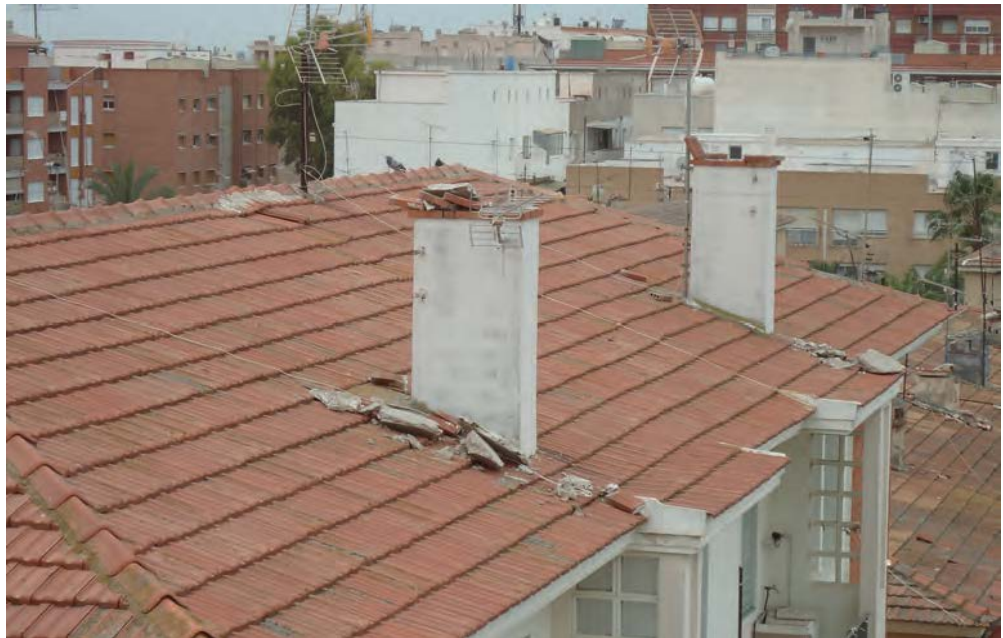
▲ Photograph 8-16

In addition to the parapets, the stability of all other roof masonry (chimneys and bulkheads), particularly where located near the façade and liable to fall on pedestrians if they fail, would need to be checked. In some cases a structural member may be close enough to anchor such elements, deploying solutions as simple as shown in Photograph 8-15. These measures should be taken scrupulously and include even secondary elements such as chimney caps (note the trail of rubble between these elements and the edge of the roof in Photograph 8-16).

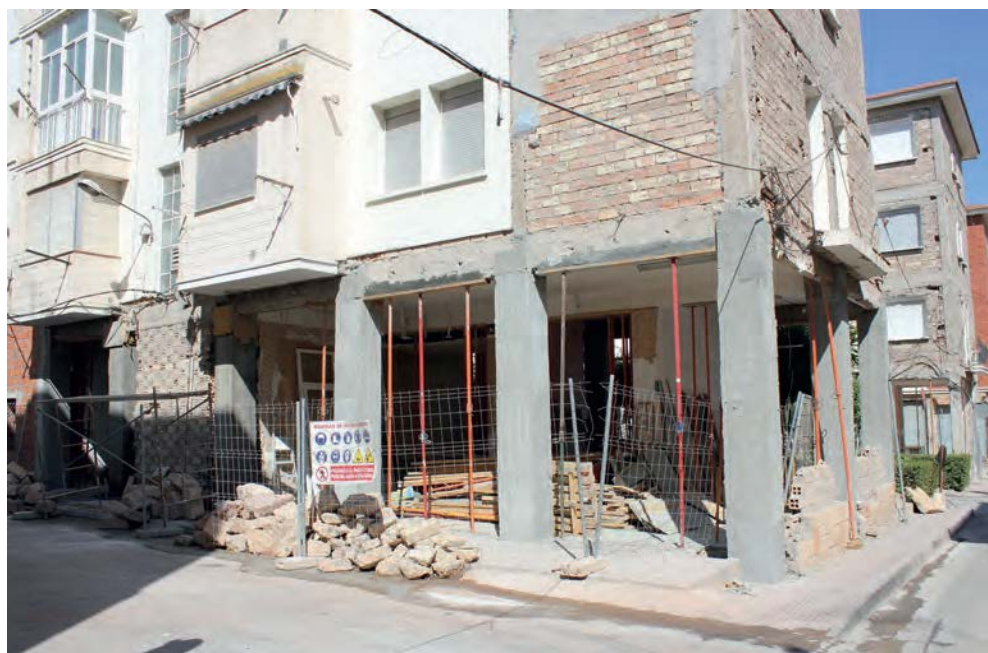
▲ Photograph 8-17

- An example of this can be found in ground storey column and masonry wall strengthening, a solution generally observed in the city. In some cases the result was greater storey stiffness and strength both. The columns were thickened (Photograph 8-17) and the walls strengthened. But a similar earthquake would certainly generate greater stress in the non-strengthened rest of the building.

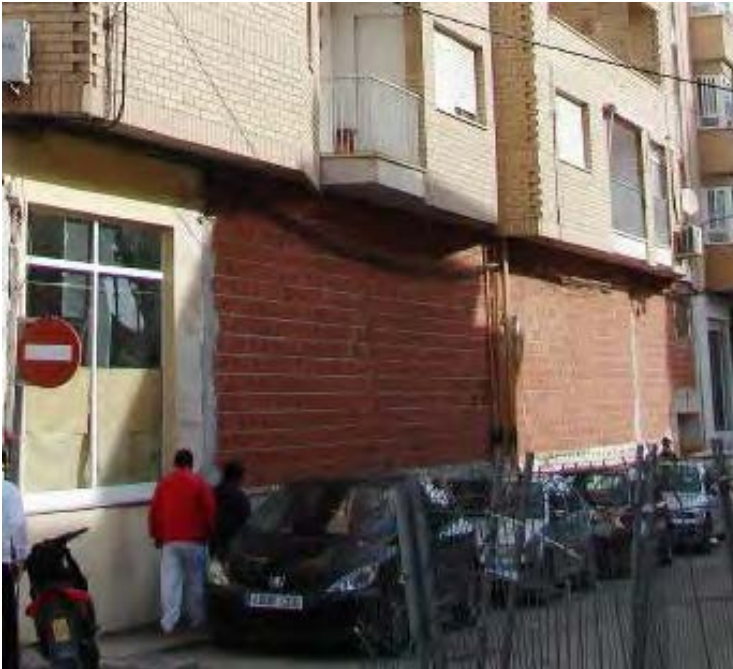
▲ Photograph 8-18

ground storey elements than on the quake itself, raising the strength of masonry walls whose failure acted like a damage-limiting fuse would appear to be illogical. In some cases, however, the ground storey enclosures were replaced with high performance masonry (thermo-clay block, as shown in Photograph 8-18).

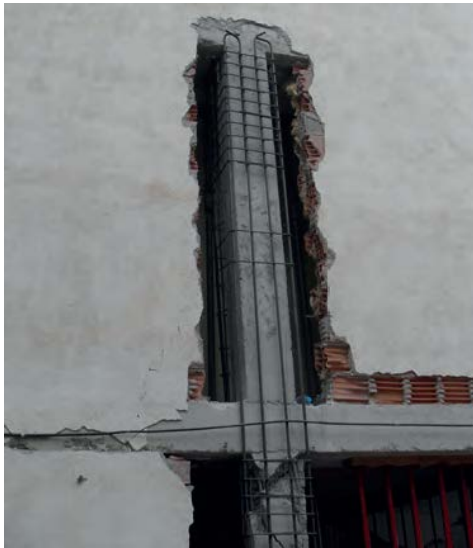
▲ Photograph 8-23

6. Note that the original buckled reinforcement bar was not replaced. Further to the discussion in item 8.4.3, the authors deem that to be unsuitable.

If the aim is to erect a concrete column around the existing column, continuity across the top and bottom joints, which is essential, is attained by positioning the longitudinal reinforcement (which acquires a more prominent role) as shown in Photograph 8-23⁶ and extending the operation to the adjacent floors as described earlier in connection with steel solutions.

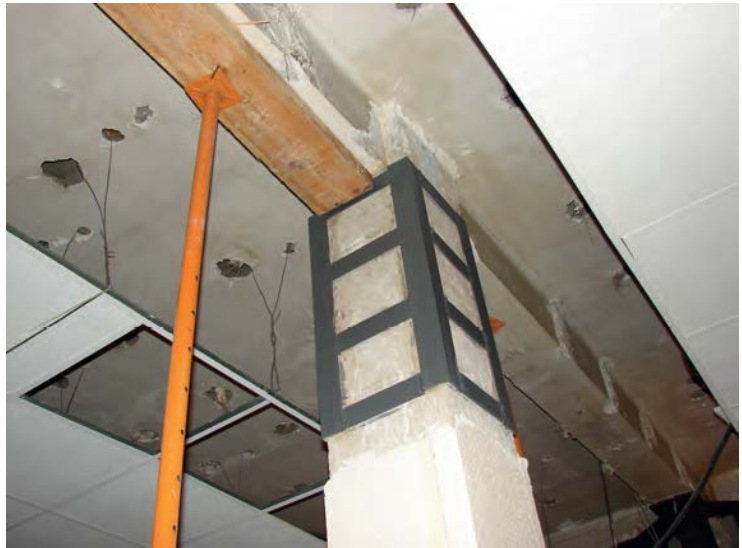
▲ Photograph 8-24

Further to that premise, they find solutions such as shown in Photograph 8-24 to be incomprehensible, for they can neither confine the existing member nor receive loads.

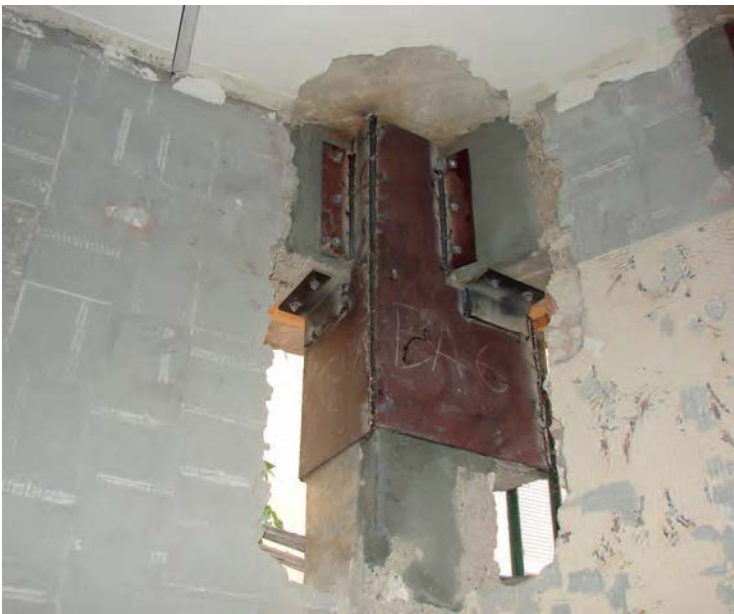
▲ Photograph 8-26

The authors are unable to understand actions such as depicted in Photograph 8-26, however, where the beams prevent the perimetric confinement of the column (no tie is formed) and the angles appear to be positioned to support the beams (as if they were to receive the respective loads). Note also that the steel generates obvious longitudinal irregularity in the column, raising the stress on the non-strengthened segment.

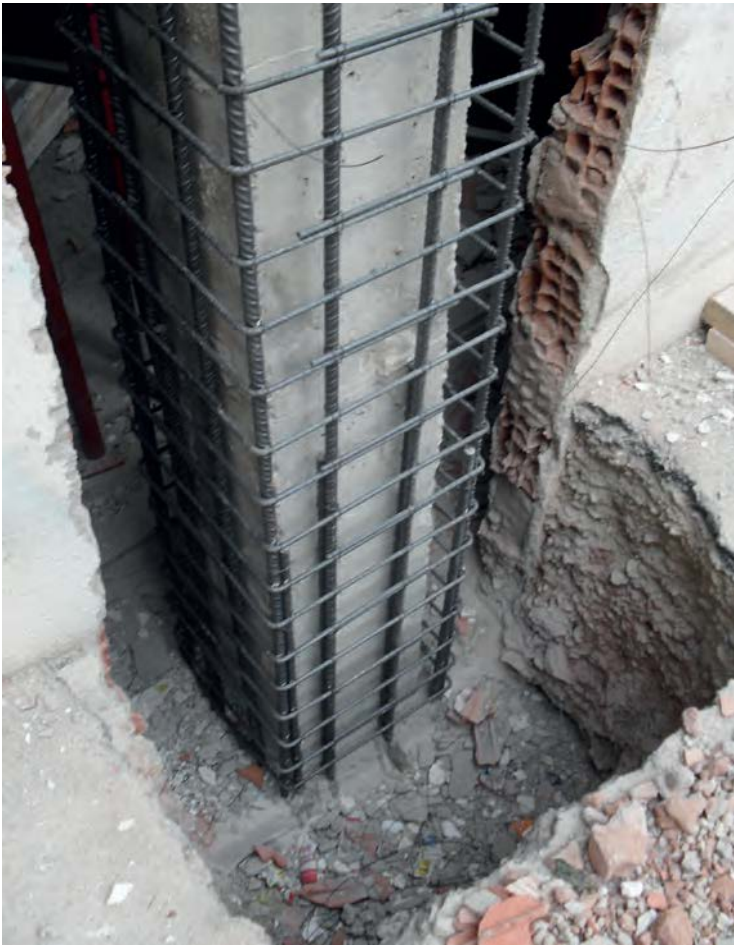
▲ Photograph 8-29

Photograph 8-29 depicts a splicing detail in tie bars for column thickening. As noted in preceding chapters, in seismic zones tie bars must be anchored in the core with 135° hooks. Alternately, the laps may be welded, but simple lapping such as shown in the photograph is never admissible.

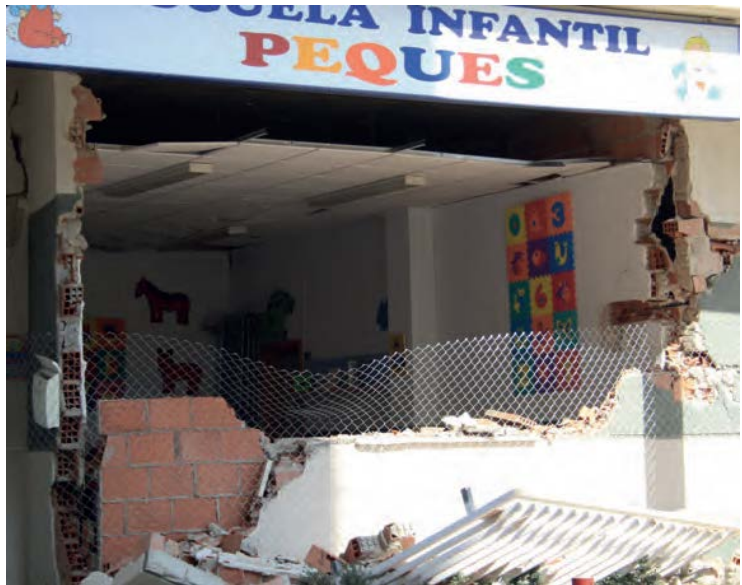
▲ Photograph 9-1

The present item addresses the widespread use of solutions that have proven to be unsatisfactory and the pressing need to adopt measures in this regard. Situations such as depicted in Photograph 9-1 warn of the need, at least in buildings that house certain activities, to bear in mind the hazards inherent in these elements.

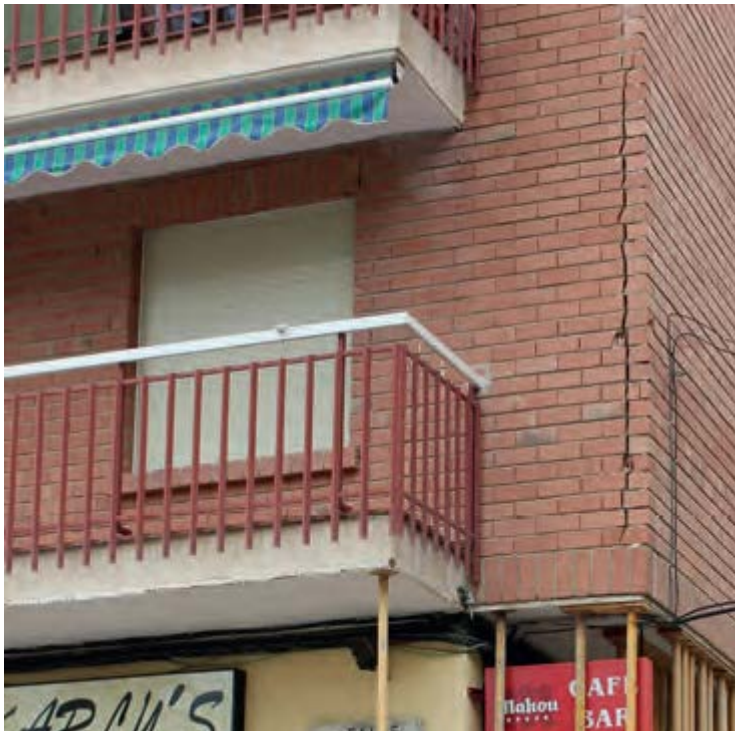
▲ Photograph 9-7

many of the types of failure observed at Lorca: parapet and façade collapse, captive or short columns, staircase collapse, pounding and so on.
